inspectmyhome

TIMBER PEST INSPECTION REPORT

In accordance with AS. 4349.3

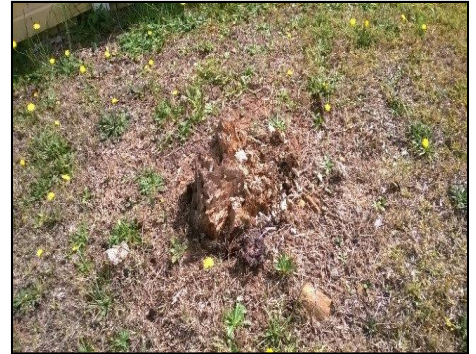
Were live termites found? **Yes**

Recommend that all active termites as stated in item 3, but not limited to be eradicated.

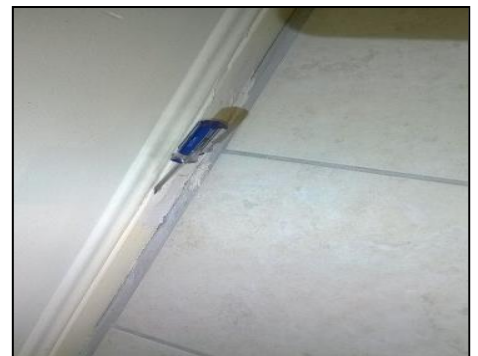
Termite damage to the skirting board in garage.

RECOMMENDATION; Where evidence of damage to building timbers exists or is undetermined, competent advice (e.g. from a licensed and practicing building contractor) should be obtained to determine the extent of any structural damage and as to the need or otherwise for rectification or repair work. See also Item 3.5 'Frequency of Future Inspections' recommendation

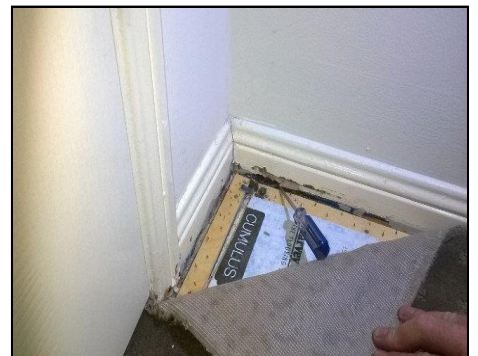
Termite damage to the skirting board in bedroom.

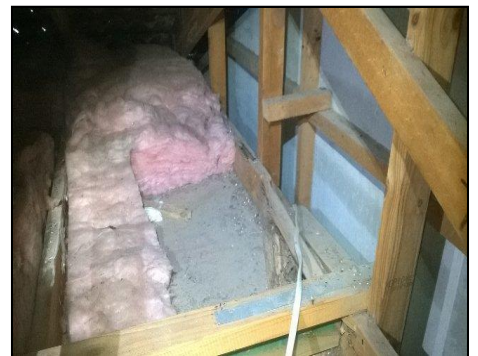
Termite damage to the roof truss.

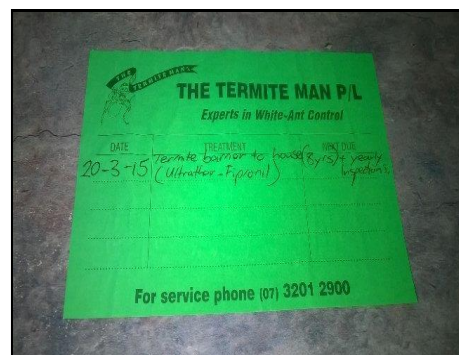
Termite treatment notice in meter box for Fipronil installed on 20/03/2015 to the perimeter. Strongly recommend obtaining all documentation pertaining to the termite management system in place, any warranties given and if the warranties are intact and transferable prior to the contract becoming binding.

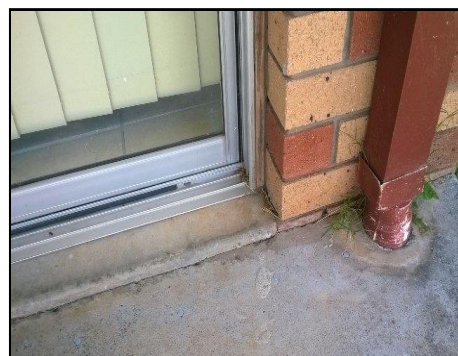
Visual evidence was found of drilling which is consistent with a termite barrier treatment, recommend obtaining all documentation pertaining to this treatment and its warranties, etc. Also, was this treatment a) a preventative treatment or b) for the eradication of an infestation and if so, what damage was caused and relevant repairs made. Documentation from the pest control company that carried out the treatment and from the builder that carried out the repair / investigation works should be obtained prior to the contract becoming binding.
