## **BUILDING INSPECTION REPORT**

In accordance with AS 4349.1

14 Jobs Road, Westbrook, Qld 4350

15 November 2022

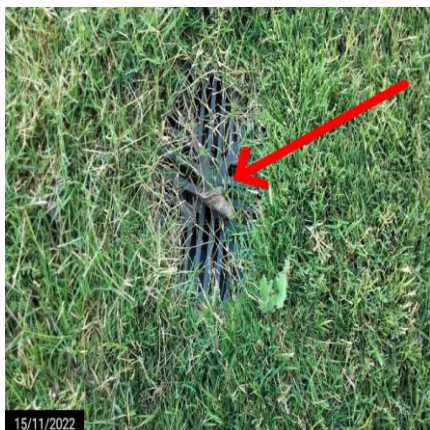
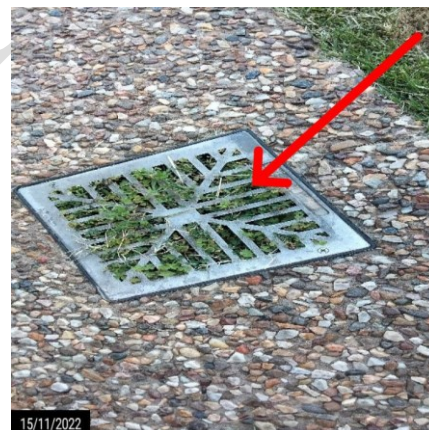
##### Blocked drainage grates.

Blocked drainage grates

Drainage that is installed to move surface water would have to be kept open and clear at all times to function. No calculations have been made as to whether the drainage installed is adequate to move water in all situations. Recommend drainage grates be cleaned and cleared. Seek a plumber to fix.

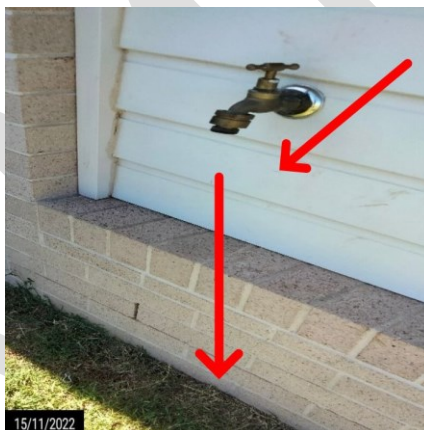
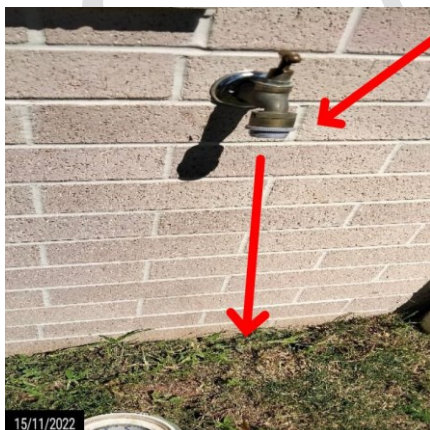
Hot water system, air-conditioners, taps dispersing water close to the house foundations. Strongly recommend contacting plumber to divert away from the building to drainage or repair.

Water dispersion close to the house

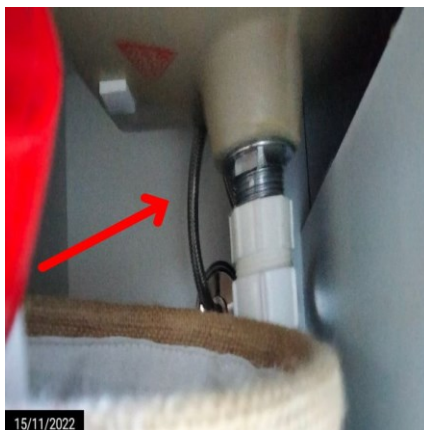
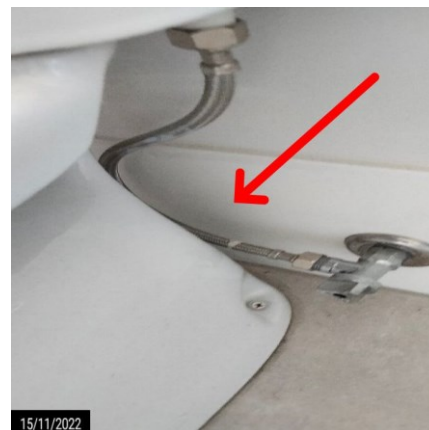
The inspector noted braided flexible hoses installed to mixer taps/ water outlets inside cabinets. It is advised regular maintenance/inspection is carried out to identify rust/ deterioration to connections and hoses to prevent water damage. Recommend seeking further advice from a licenced and practicing plumber.

Flexible hose to basins

Flexible hose to toilet

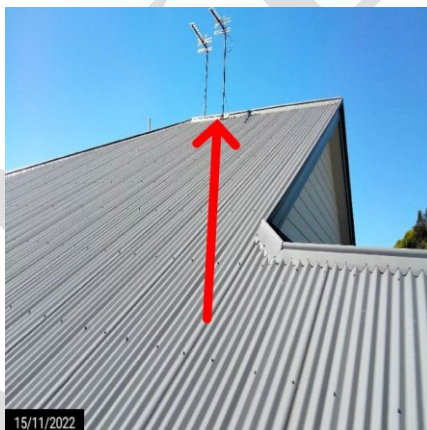
Maintain silicone sealants to all roof infrastructure

Silicone to roof flashings and penetrations will require on-going maintenance. Refer to 'General Maintenance Tip' sheet.

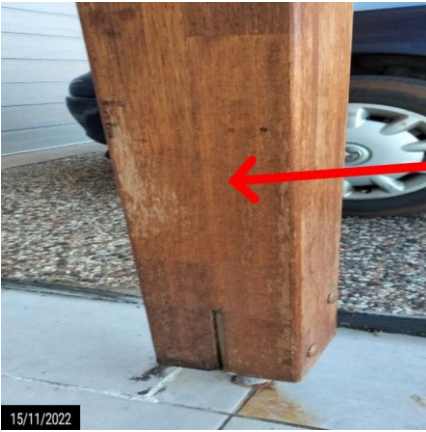
Posts require repaint

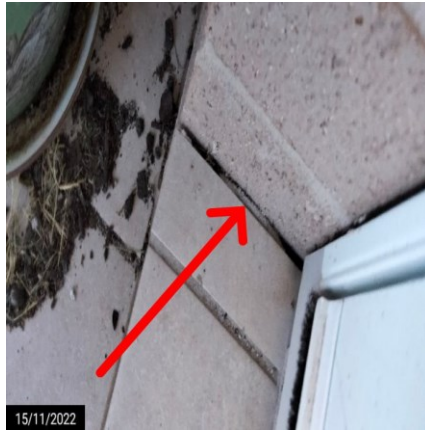
RegROUT required to porch sill

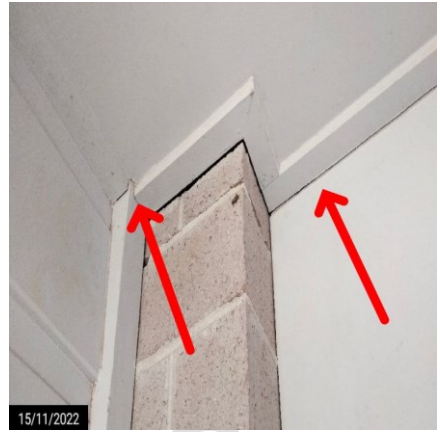
Shrinkage cracking was detected to internal and external timber mouldings, recommend to monitor these areas regularly for any changes. Please read the attached information from CSIRO that classifies these cracks/movement as Categories 0 and 1.

Shrinkage cracking

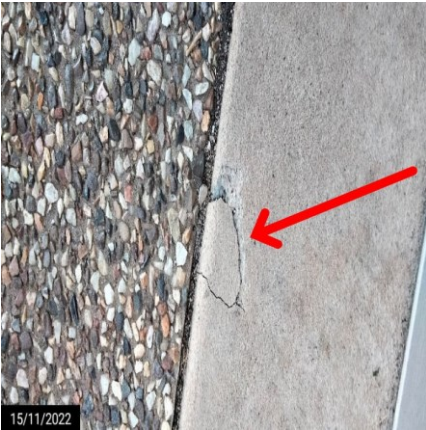
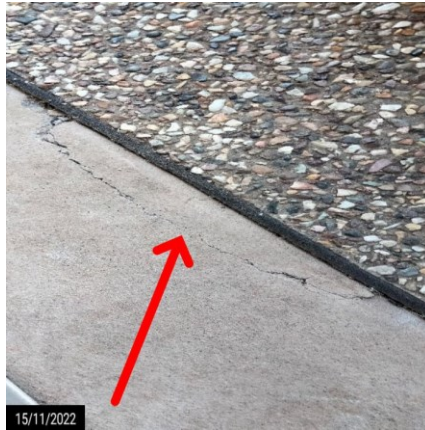
Cracking was detected to sections of concrete pathways and/or driveway. This is a common issue with a large percentage of homes and can be caused by many differing factors including poor ground preparation, inadequate steel reinforcing, etc. Cracking in concrete is common and is not always attributable to unsatisfactory workmanship. Common causes of cracking include shrinkage stress, stress due to trees, commercial or heavy vehicle traffic, soil movement due to changes in the moisture content as a result of garden watering or drainage problems. Repairs are not considered essential, monitor for further changes.

Cracking to paths

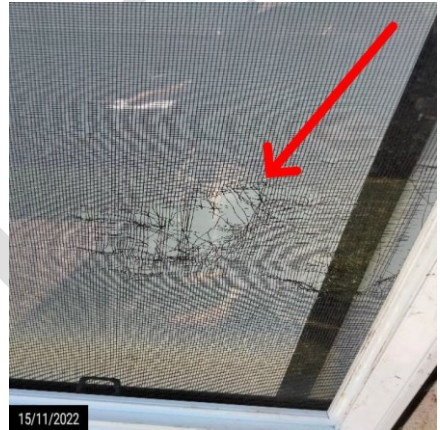
Damaged insect screens

Some insect screens require maintenance and repair. Contact a carpenter to fix where required.

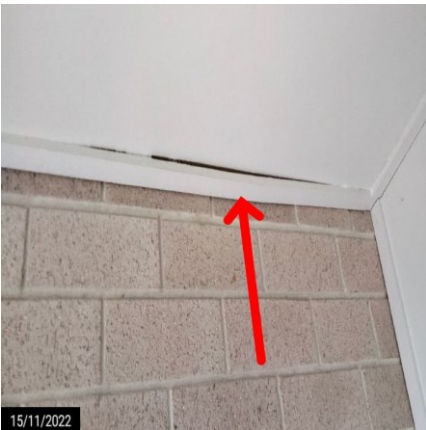
Loose soffit mouldings

Some loose internal and external timber mouldings. Contact a carpenter to fix where required.

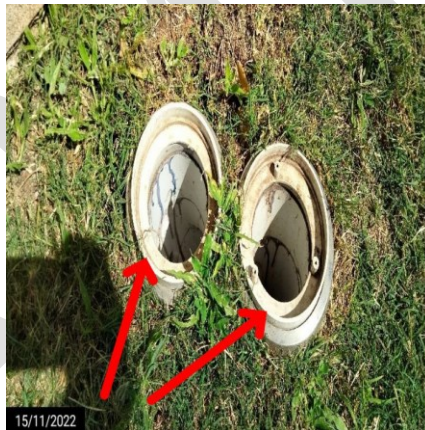
Missing IOU Caps

External IOU covers are missing. Contact a plumber to replace.

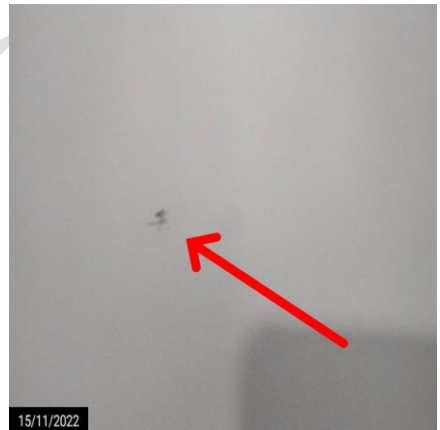
Popping ceiling screws

Popping nails to fixing points in ceiling linings were detected. Re-fixing, patching and painting will improve defect noted. Recommend seeking further advice from a licensed and practicing plasterer/gyprocker.

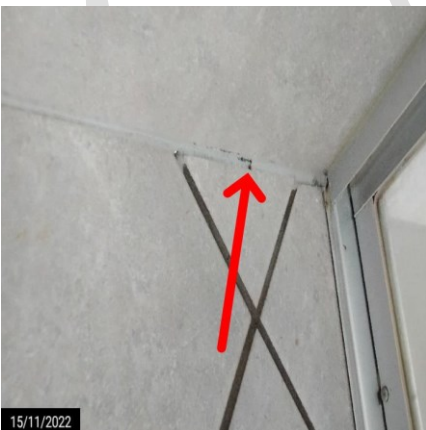
Silicone reseal required to ensuite shower

Replace/install sealant to the internal corner and around the base of ensuite shower. Flexible sealant is required to these areas where differential movement takes place. Recommend seeking further advice from a licenced and practicing wall and floor tiler.

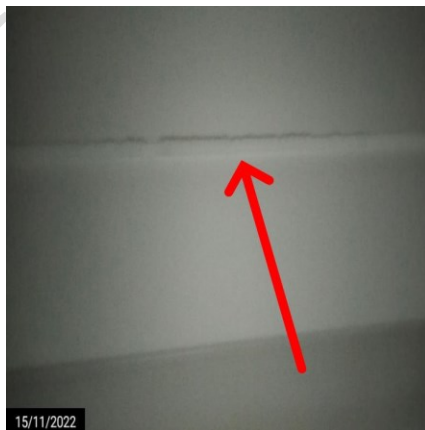
Minor cracking has occurred to areas of the ceiling cornices where they are attached to the walls and ceilings. This is a common issue with most homes fitted with cornices. Patching and painting will improve the overall appearance. Recommend seeking further advice from a licensed and practicing painter and decorator.

Cornice cracking

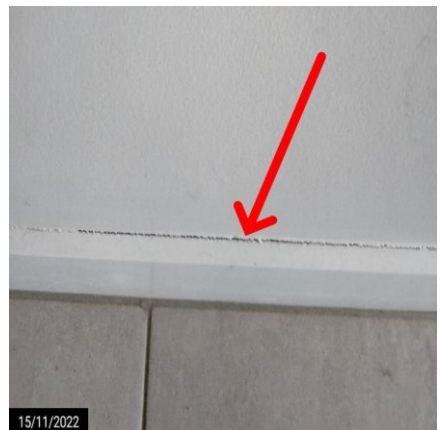
Loose skirting

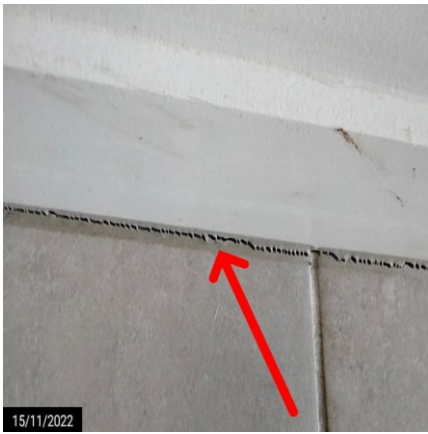
Reseal required to skirting and tiles

Recommend installing/replacing sealants to internal corner and base of skirting and floor tile. Check and maintain sealants and grouting.

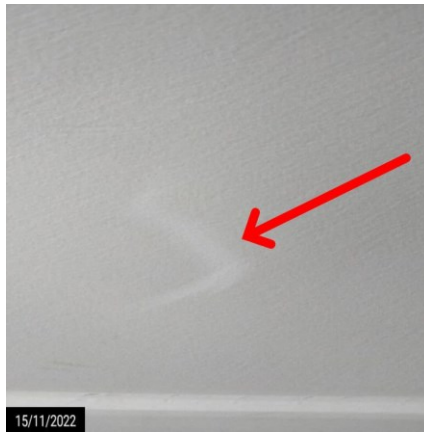
Various minor marks/holes/scuffing to plaster and paint work throughout, this is consistent with general wear and tear for a property of this age. Patching and painting will improve the overall appearance. Recommend seeking further advice from a licensed and practicing painter and decorator.

Dents to walls

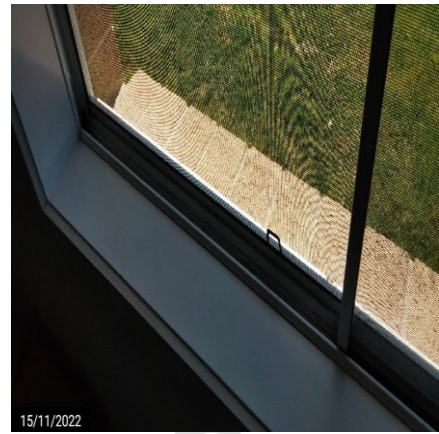
Aluminium sliding window/door rollers require maintenance, heavy to slide. Refer to general maintenance tip sheet.

Sliding doors and windows require maintenance

Aluminium sliding windows/doors in general require maintenance to provide smooth operation (e. g. lube rollers, replace deteriorating seals). Refer to 'General Maintenance Tip' sheet.
