CONDITION INSPECTION REPORT

1 (Lot 307) Home Place, Bushland Beach QLD 4818

17 June 2022

This is a Handover Report as requested by the client for a new property.

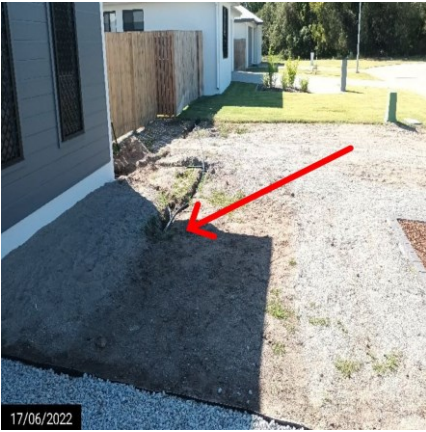
Incomplete landscaping.

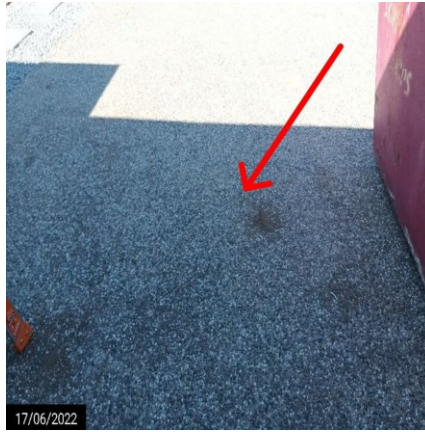
Builders clean incomplete to concrete driveway.

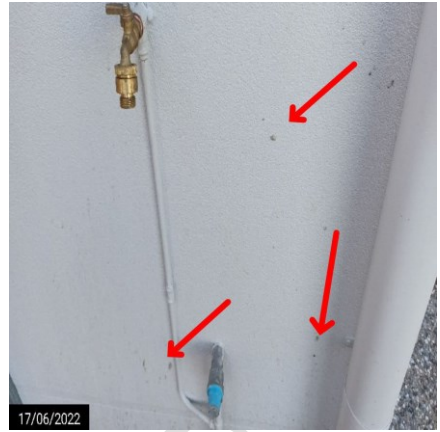
Splatter to front left corner masonry wall.

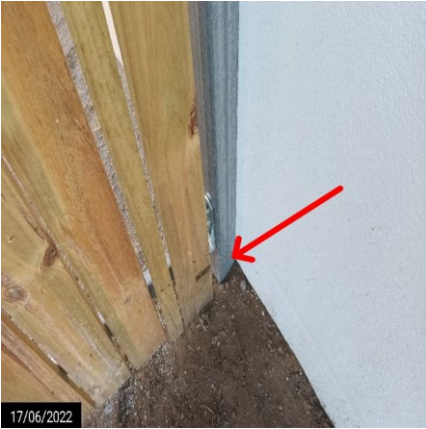
Fence post attached to house in contact with ground. May void termite management warranty.

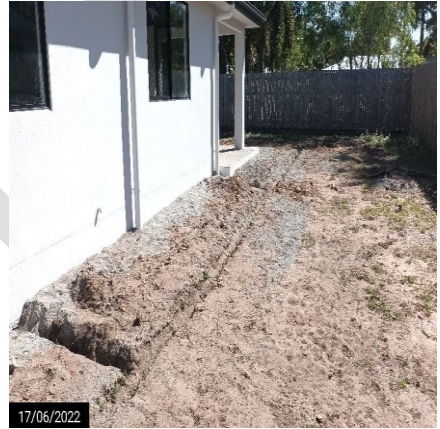
Landscaping incomplete.

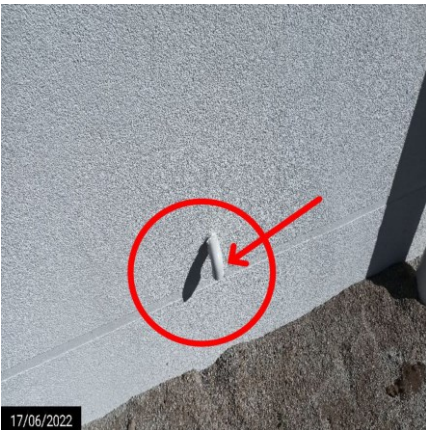
Air conditioning overflow is dispersing close to foundations.

All surface water should be diverted away from house footings / foundations. Refer to attached CSIRO Information Sheet.

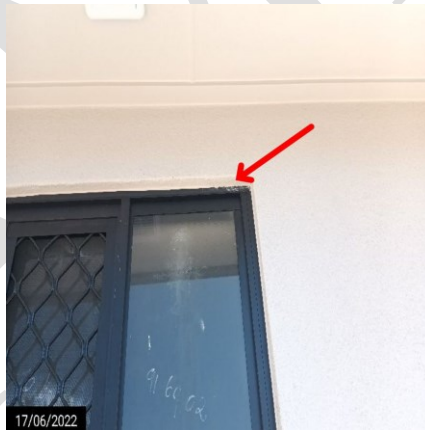
Paint marks to window frames (external elevations).

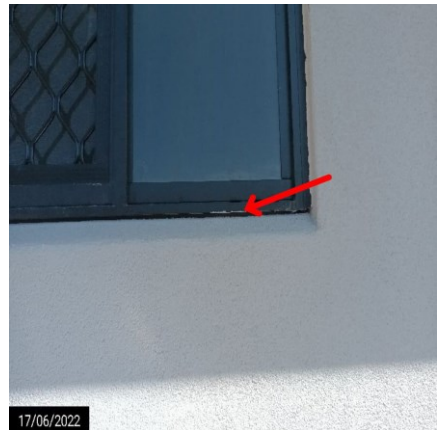
Scratch to ensuite window powdercoat finish.

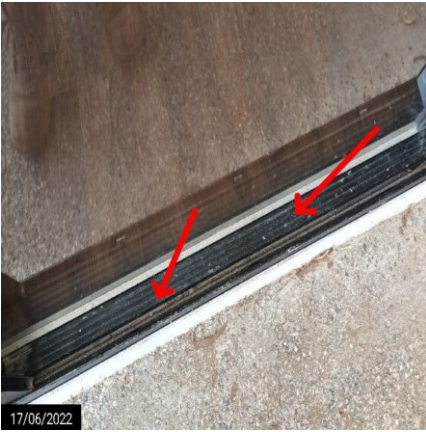
Aluminium sliding door and window track clean required (all frames).

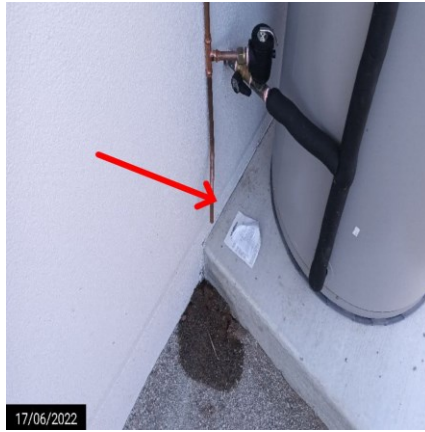
Hot water overflow dispersing close to foundations.

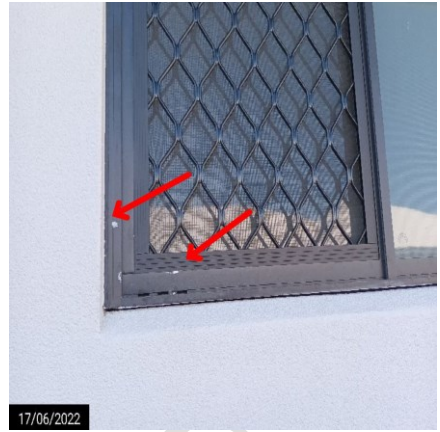
Paint splatter on window frames (all windows).

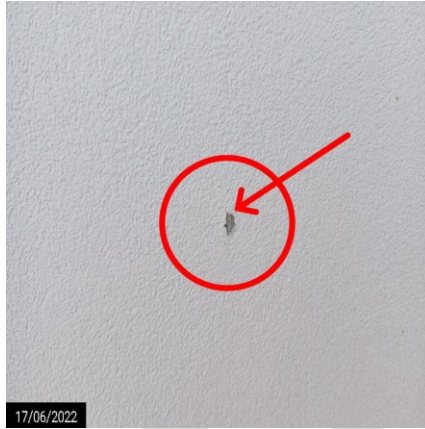
Damaged render finish behind left hand pedestrian gate.

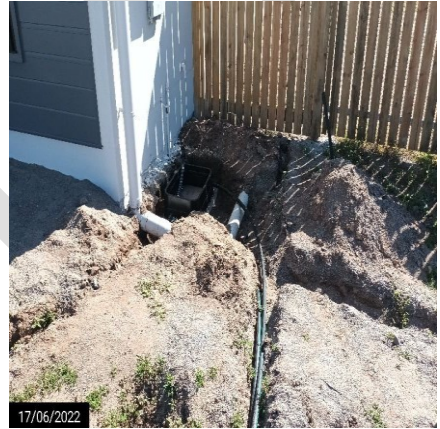
Landscaping incomplete.

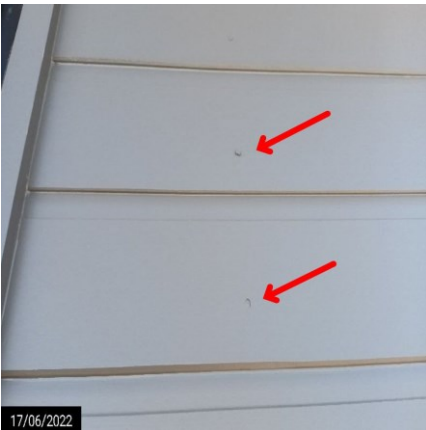
Cladding fixing nails popping.

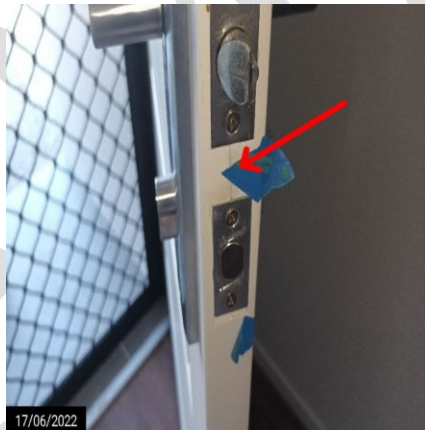
Cracking to front entry door (locks).

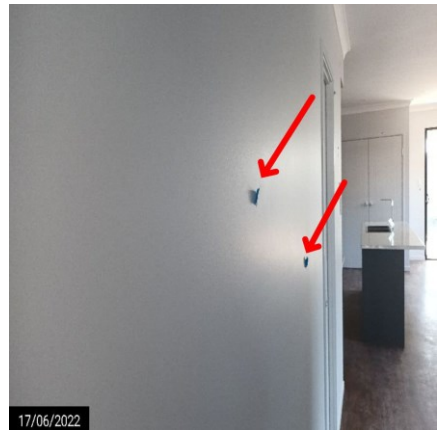
Incomplete painting to entry hall walls , (marks along full length of wall).

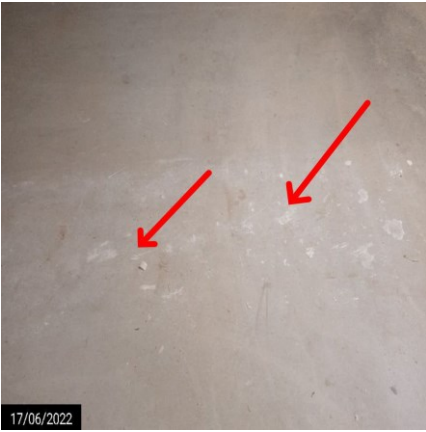
Paint and plaster splatter on garage concrete floor.

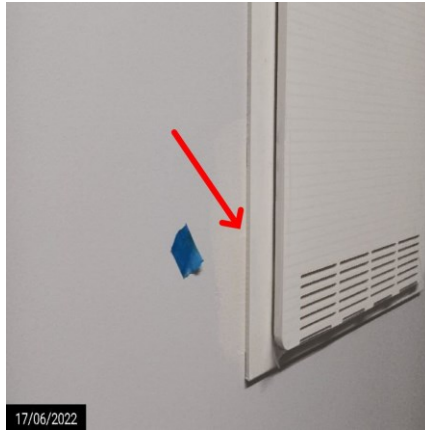
Plaster patches around communication panel on rear garage wall.

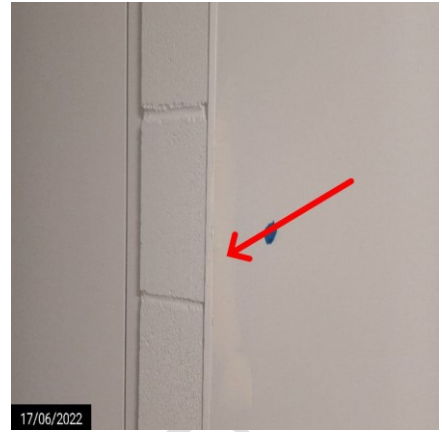
Marks to paint finishes along garage plaster walls.

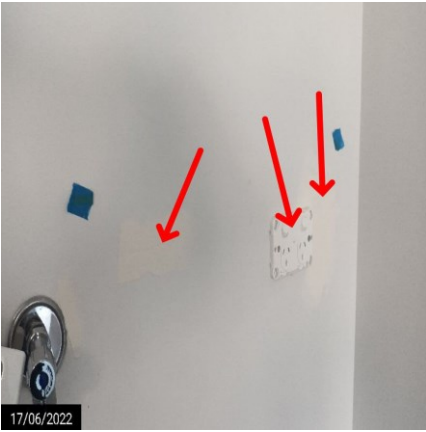
Marks to paint finishes to garage/laundry plaster walls.

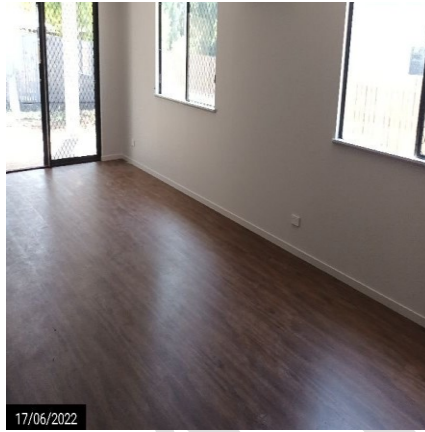
Builders clean incomplete.

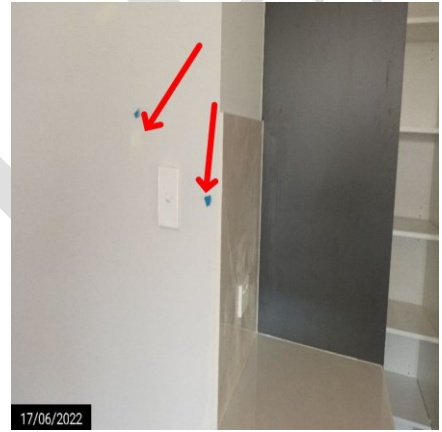
Marks to paint finish along plaster wall linings next to kitchen.

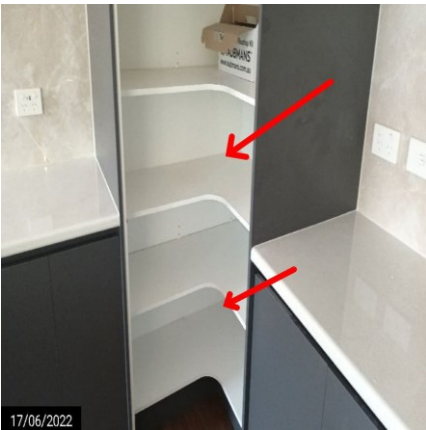
Kitchen pantry doors not installed.

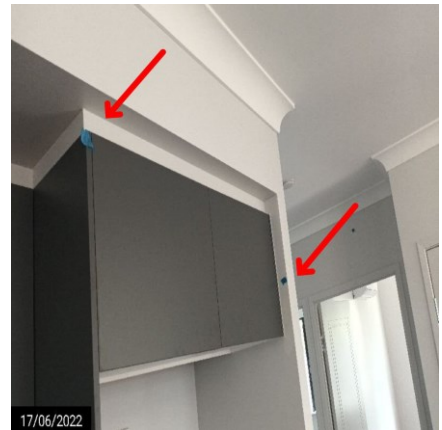
Marks to paint finish above kitchen overhead cabinets.

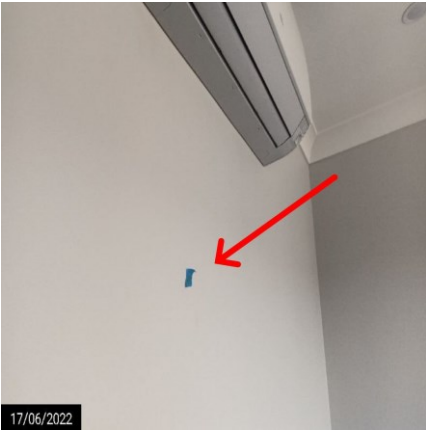
Marks to bedroom 2 plaster wall linings (consistent to all walls).

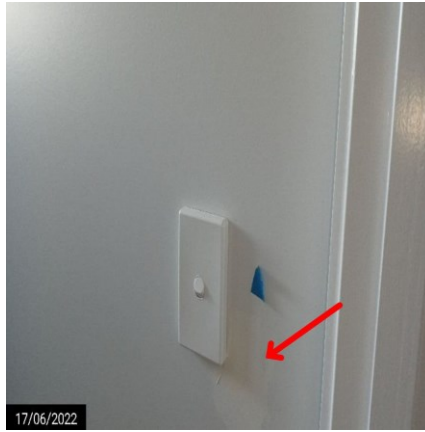
Marks to WC plaster wall linings (consistent to all walls).

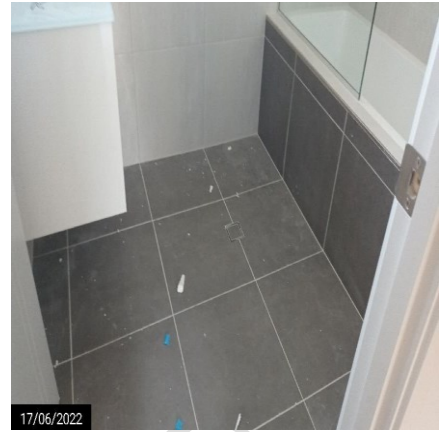
Builders clean incomplete (bathroom).

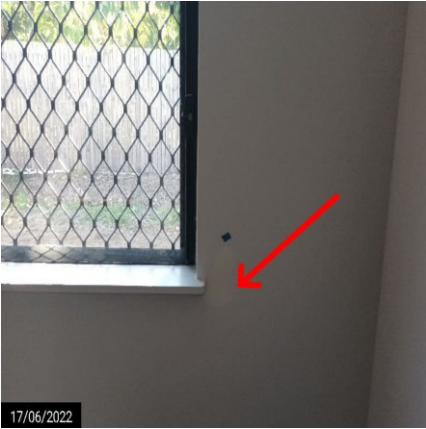
Marks to paint finish near bedroom 3 window (consistent to all walls).

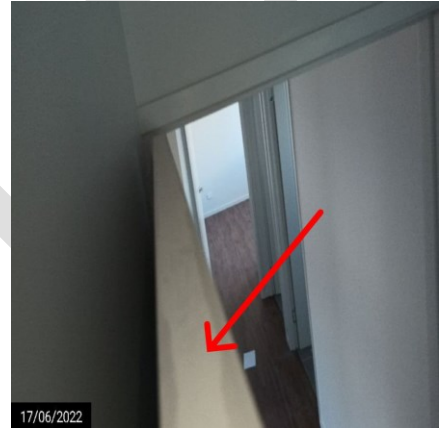
Top and bottom of some room doors not painted as per manufacturer requirements.

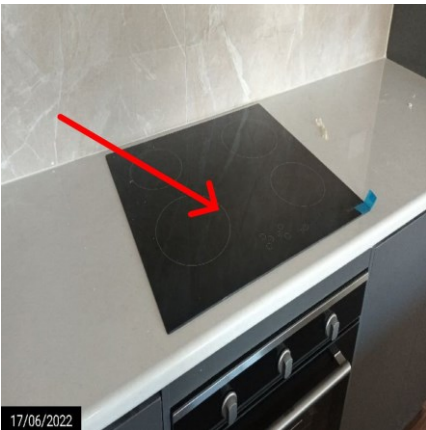
Hot plate loose in cabinet.

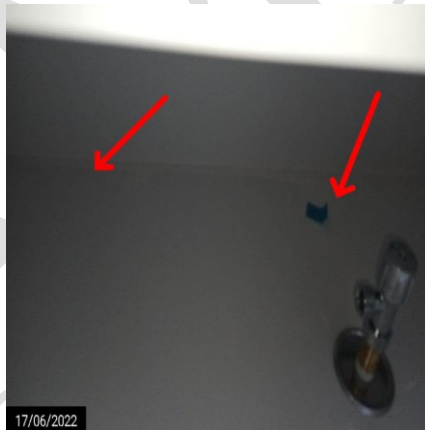
Poor paint finish to plaster wall linings above refrigerator opening.

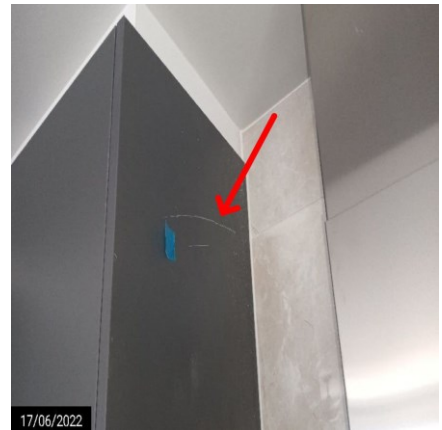
Scratch to left side of overhead cabinet panel (rangehood).

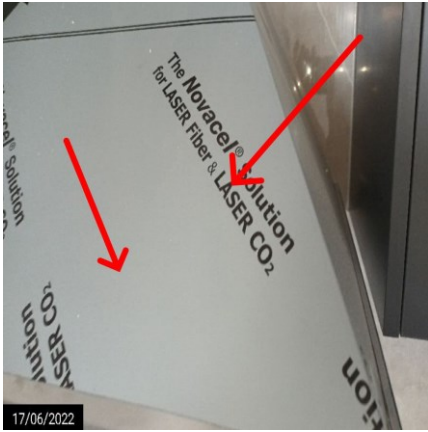
Protective cover not removed from rangehood.

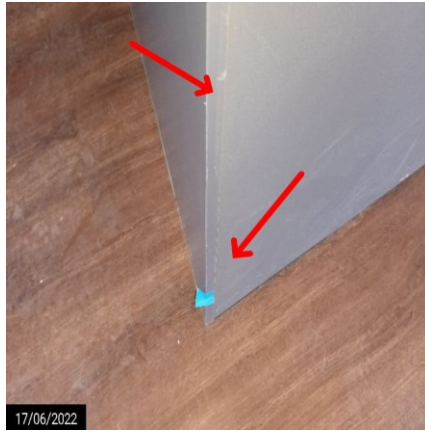
Marks/scratches to kitchen sink cabinet panels.

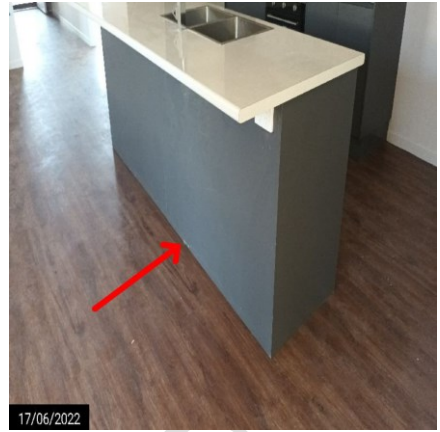
Marks/scratches to kitchen sink cabinet panels.

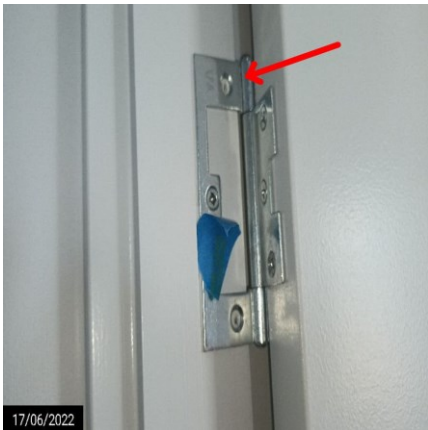
Door hinges screws missing to all doors.

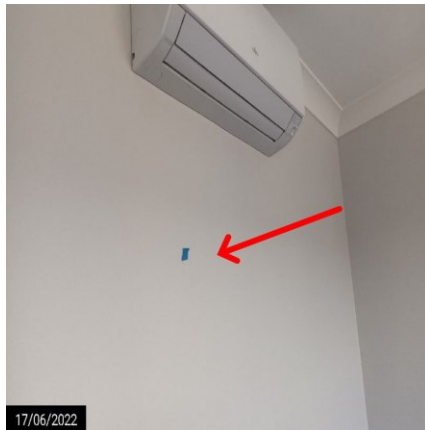
Marks to bedroom 2 plaster wall linings.

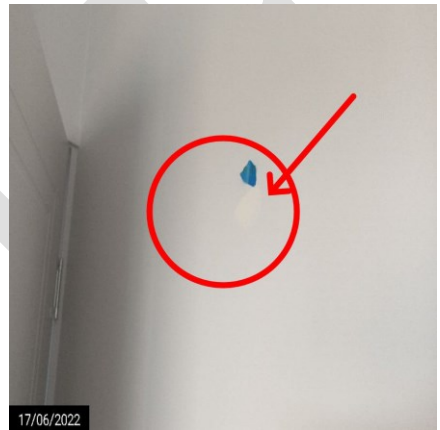
Mark to bedroom 2 plaster wall behind door.

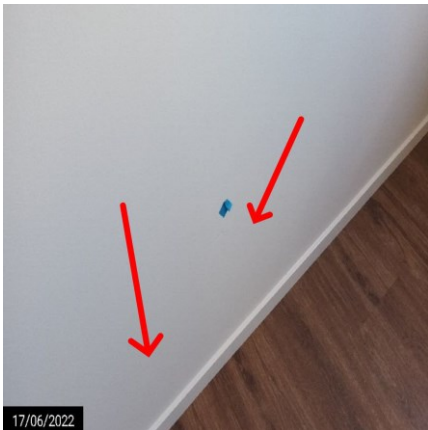
Marks to bedroom 2 plaster wall linings (all walls).

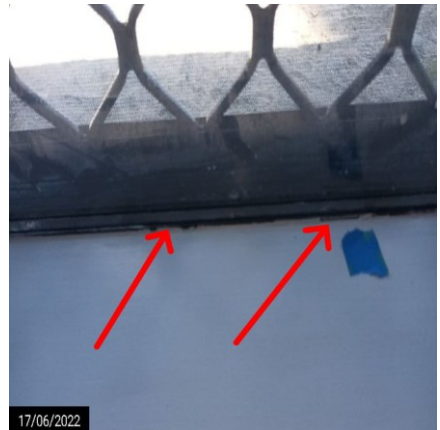
Poor paint finish around window frames (consistent throughout dwelling).

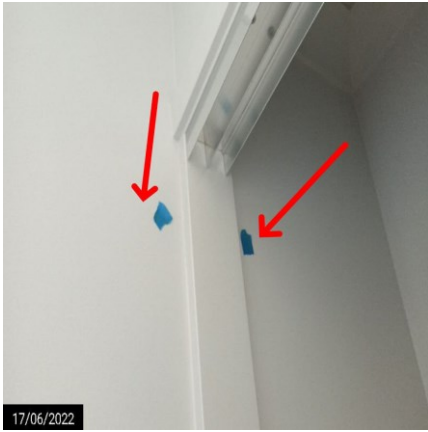
Marks to plaster wall linings inside bedroom 2 and 3 robes.

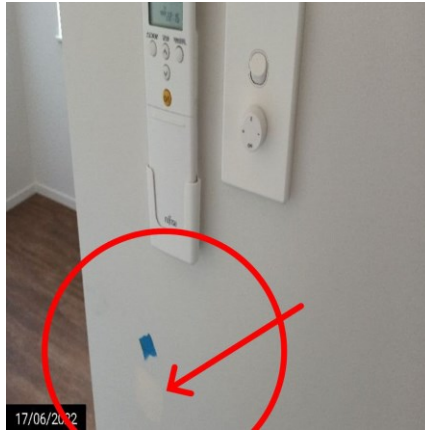
Repairs to plaster wall linings consistent throughout dwelling.

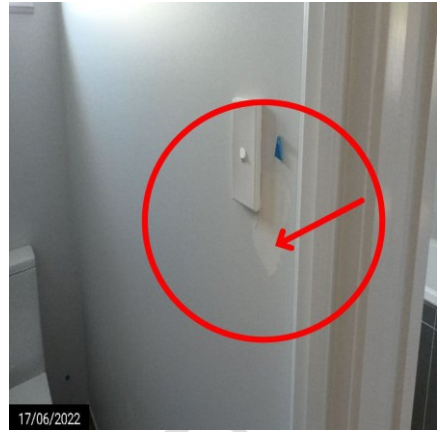
Marks to WC plaster wall linings.

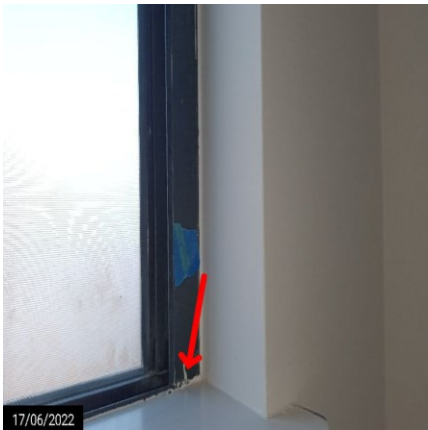
Poor paint finish around window frames.

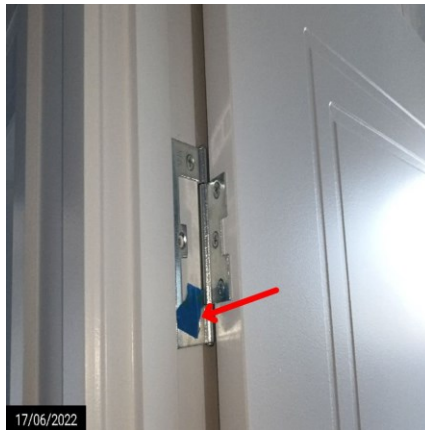
Door hinge screws missing (consistent all doors).

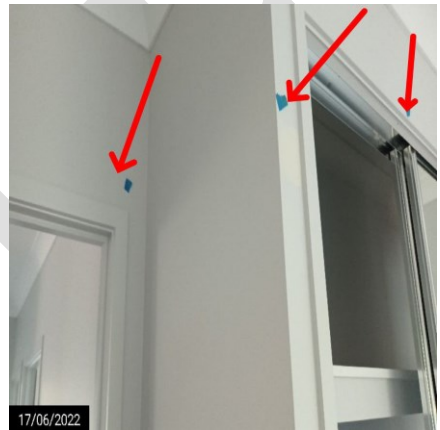
Marks to bedroom 3 wall linings and robe timber architraves.

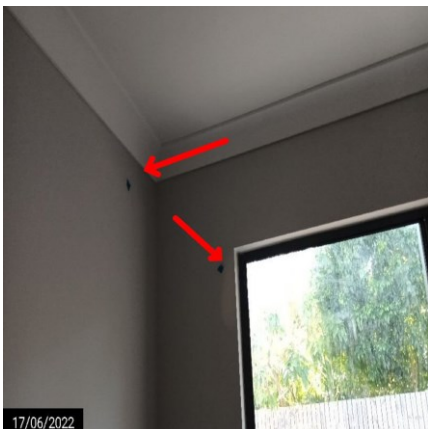
Marks to bedroom 3 plaster wall linings (consistent throughout).

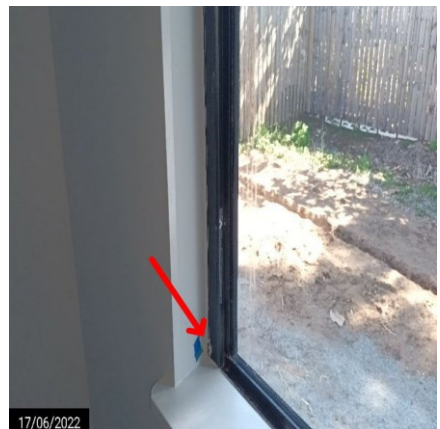
Poor paint finish around window frames (all rooms).

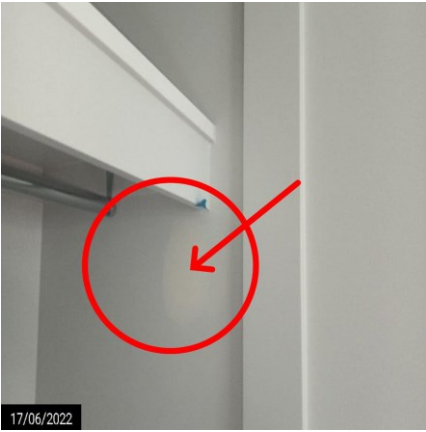
Marks inside bedroom 4 robe.

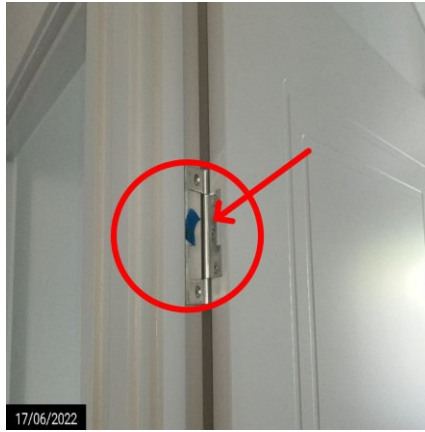
Door hinges screws missing (consistent all doors).

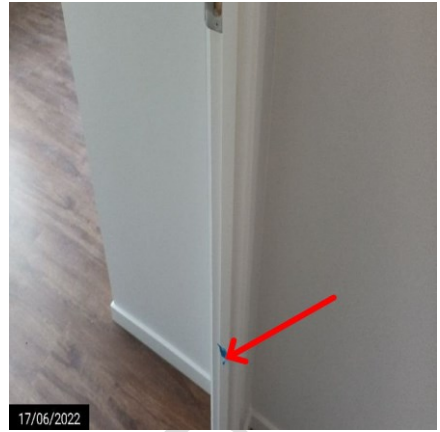
Marks to bedroom 4 door frame.

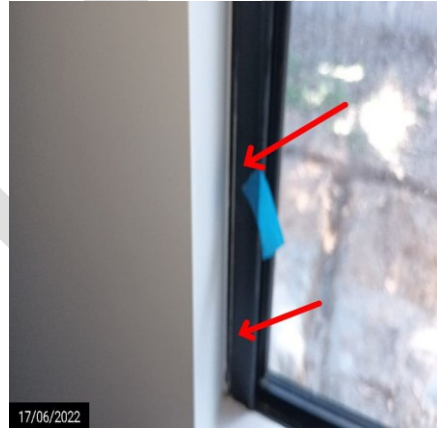
Poor paint finish around window frames.

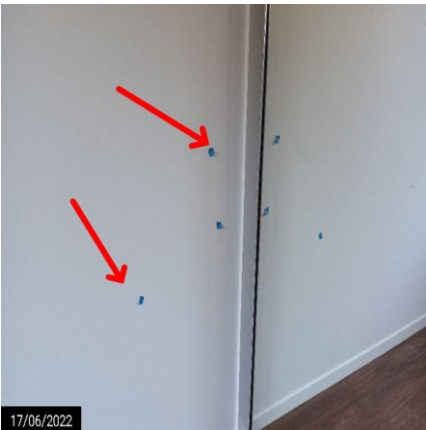
Marks to bedroom 4 plaster wall linings (consistent to all walls).

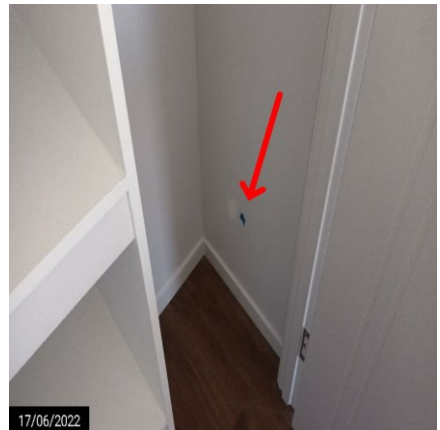
Marks to plaster wall linings inside bedroom 4 robe.

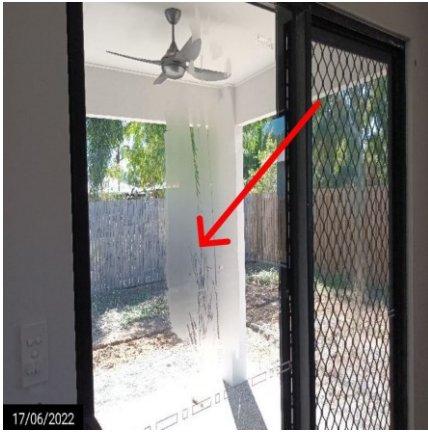
Builders window clean incomplete.

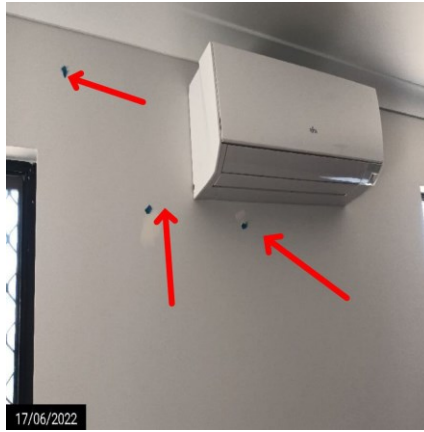
Marks to loungeroom plaster wall linings (all walls).

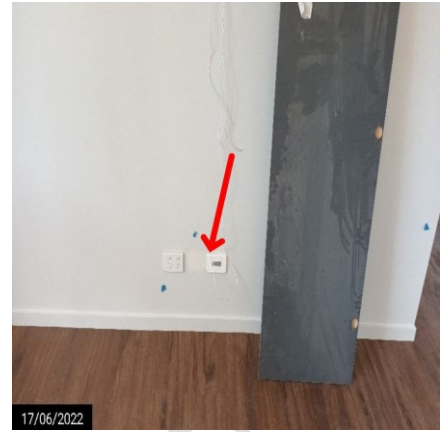
Marks to loungeroom plaster wall linings (all walls).

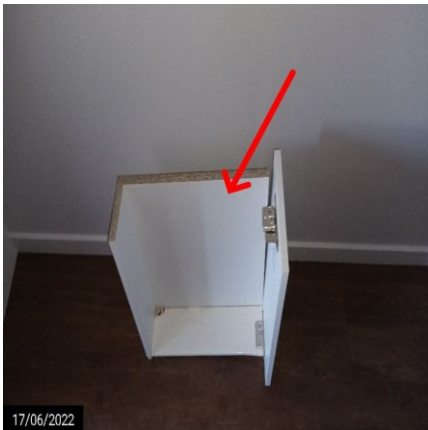
Damaged cabinet drawer to bedroom 1 robe.

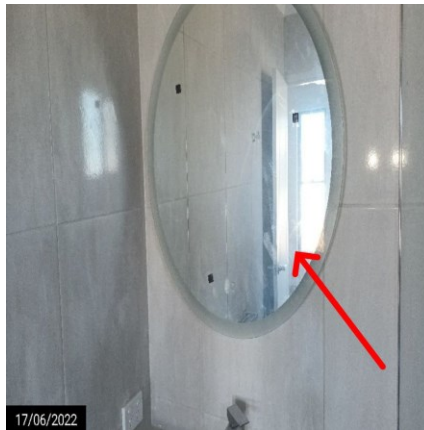
Loose fitted mirror above ensuite and bathroom vanity cabinet.

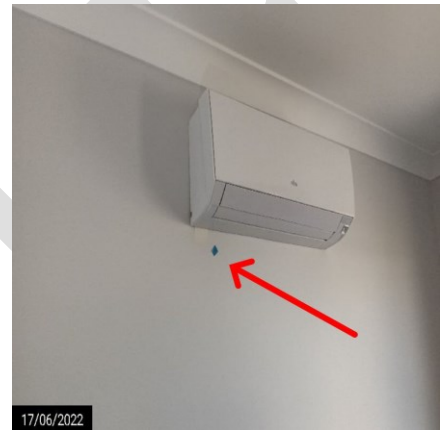
Marks to bedroom 1 plaster wall linings (all linings).

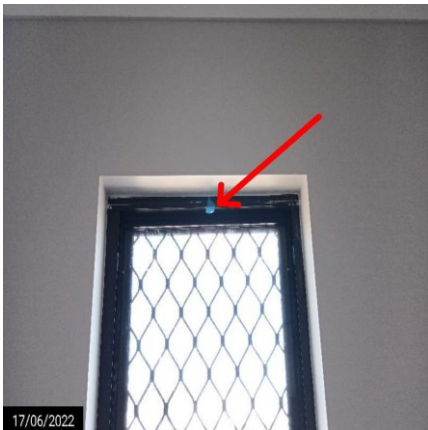
Scratch marks to bedroom 1 window frames.

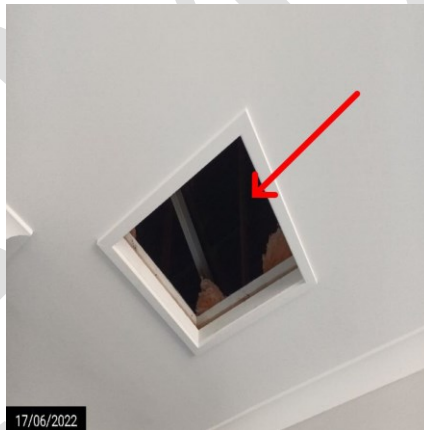
Manhole cover missing.

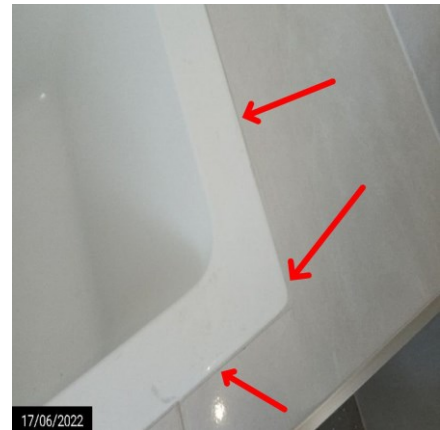
The bath is not correctly installed. Sealants will have to be kept fresh in this area or water will leak between bath and wall causing timber damage.

Check and maintain sealants to all wet areas.

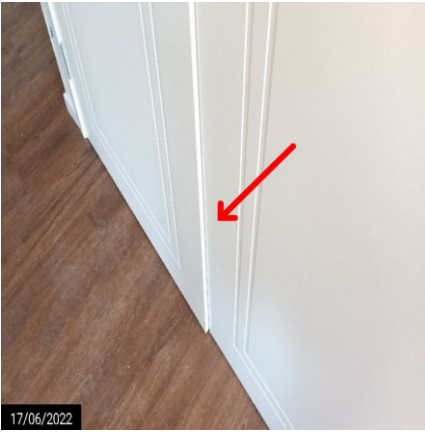
Some doors require minor adjustments to ensure correct operation. Loungeroom linen door twisted.

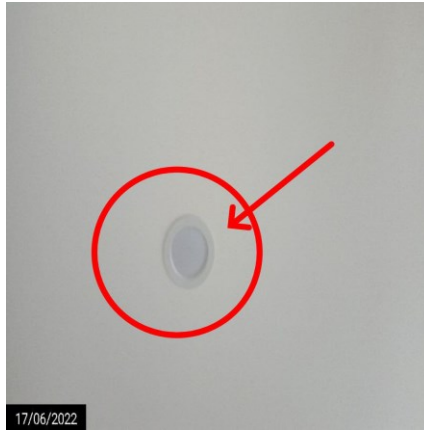
The Australian / New Zealand standard committee released an amendment to AS/NZS 3000:2007 (Wiring Rules December 2012). Among many other additions or alterations to the Standard, a new Clause 4.5.2.3.2 requires the installation of a warning sign. Where recessed downlights are installed in an accessible roof space, a permanent and legible warning sign shall be installed in the roof space adjacent to the access panel, in a position that is visible to a person entering the space. AS 1319 (also known as AS/NZS 1319) sets out lettering height, font, viewing distance and the specific colour of yellow background for this sign. The sign must be fitted within the roof space, in view and within 2m of roof void access panel.

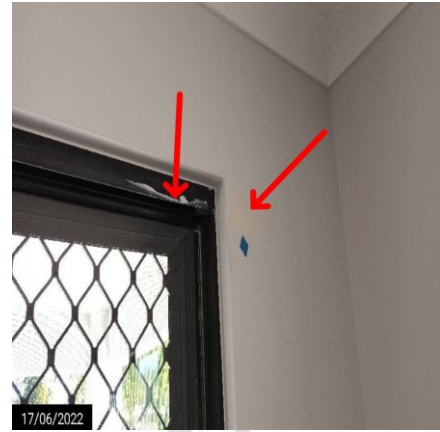
Marks to walls and window frames consistent throughout dwelling.
