TIMBER PEST INSPECTION REPORT

13579

113 Olive Street, Regents Park Qld 4118

26 August 2022

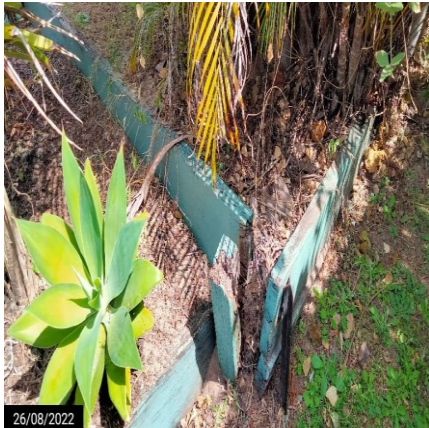
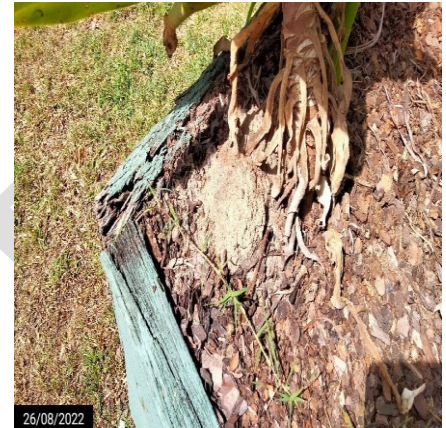
Timber retaining walls

Termite damage or workings were located in the following: **Evidence of termite activity/ workings/ damage was located but not restricted to the following areas timber retaining walls rear yard, If termite activity and/or damage and/or workings is found to the structure or in the grounds of the property on the day of inspection then termite activity and/or damage and/or working may exist in concealed areas of building structure. In this case a further invasive inspection is strongly advisable by a suitably licensed and practicing Building Contractor specialising in Termite Rectification and Repair Works to further investigate the building for the most appropriate method of rectification and the probable cost of rectification works as extensive structural damage may only be found when the structure is empty and furniture, storage, large sections of wall and ceiling linings, cladding or insulation are removed to reveal previously concealed timbers and wall/ceiling linings. NOTE: A further and invasive inspection is strongly recommended by Inspector prior to contract becoming binding to inspect inside concealed areas. Termites are capable of extensive activity and/or damage over a short period where the conditions are conducive to such activity. The client should be aware that significant damage and activity can occur in a period as short as a few weeks. Due to the unpredictable nature of termite behaviour, termites may be present but undetectable or may have temporarily vacated a location at the time of inspection. The client is strongly encouraged to implement recommendations in this report as a matter of urgency to reduce the risk of such activity prior to contract becoming binding.**

RECOMMENDATION; Where evidence of damage to building timbers exists or is undetermined, competent advice (e.g. from a licensed and practicing building contractor) should be obtained to determine the extent of any structural damage and as to the need or otherwise for rectification or repair work. See also Item 3.5 'Frequency of Future Inspections' recommendation

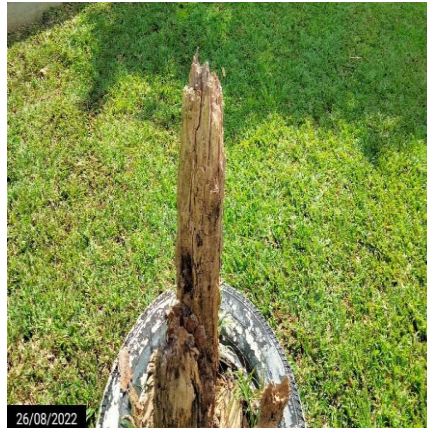
Stump

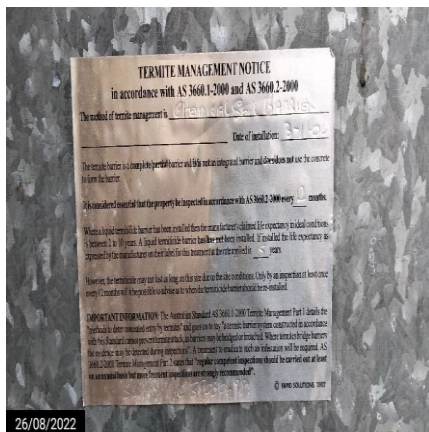
Treatment notice

Termite treatment notice in meter box installed on 3/11/04 with 5 year life expectancy. Strongly recommend obtaining all documentation pertaining to the termite management system in place, any warranties given and if the warranties are intact and transferable prior to the contract becoming binding.

Durable notice in electrical meter box indicating the possible installation of an ageing and / or deteriorated termite barrier system. Note: All relevant documents pertaining to the installation of any previous termite barrier system should be obtained by the building owner and keep on file including, any service warranties and advice in regard to the building owner's obligation to maintain the system. However, subterranean termites can bridge or breach barrier systems and thorough regular inspections of the building are necessary. If evidence of a previous treatment of termite infestation is found, and appropriate documentation is not available, it must be assumed that the termite infestation may still be active in areas of the property not inspected. Accordingly, a re-treatment may be required.

Recommend obtaining any and/or all documentation pertaining to the termite management system in place, any warranties given and if the warranties are intact and transferable prior to contract becoming binding. Regardless of the system used, regular inspections should be carried out by a QBCC-licensed and practising Pest Technician contractor, competent in Unit 8 of the National Pest Management Competency Standards or equivalent: as in accordance with section three of the 'Australian Standards' AS4349. 3 - 2010 to ensure termites have not bridged installed treatment barrier. It is recommended that inspections be at least every 12 months, or more often in high risk areas. Most infestations occur at the perimeter of the building and usually result from owners being unfamiliar with 'good practice'. For example, an existing termite management system can be bridged by building garden beds or placing wood chips up to the house, or by attaching unprotected structures such as carports, pergolas and fences to the house.

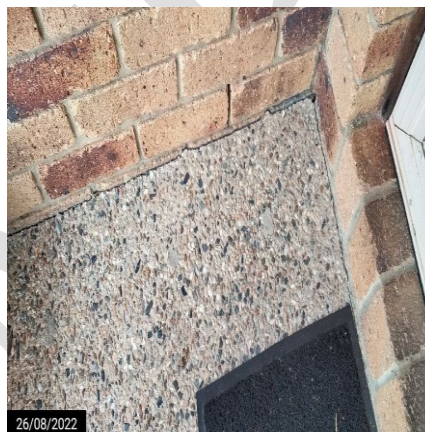
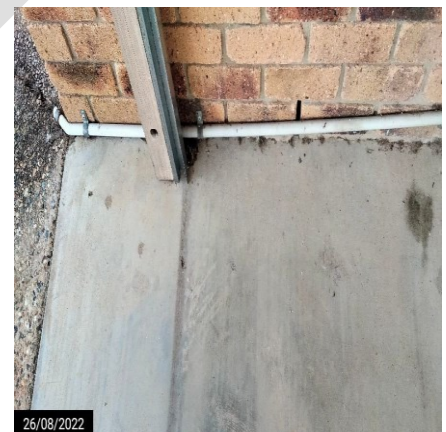
Drill holes

Visual evidence was found of drilling which is consistent with a termite treatment, recommend obtaining all documentation pertaining to this treatment and its warranties, etc. Also, was this treatment a) a preventative treatment or b) for the eradication of an infestation and if so, what damage was caused and relevant repairs made. Documentation from the pest control company that carried out the treatment and from the builder that carried out the repair / investigation works should be obtained prior to the contract becoming binding.

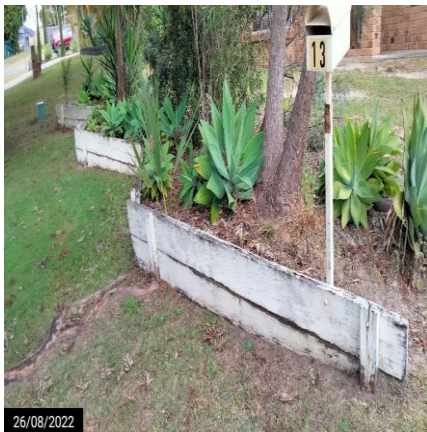
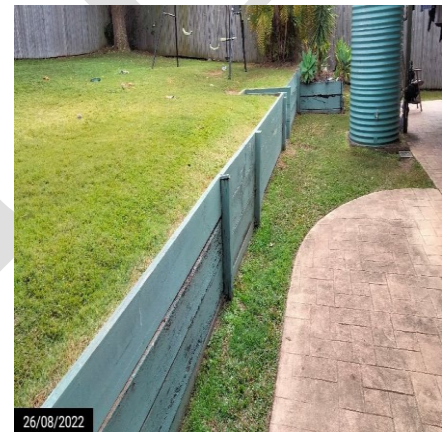
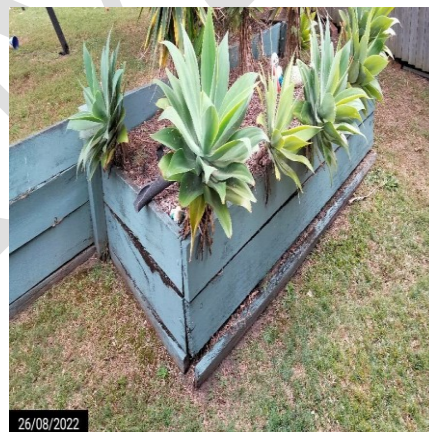
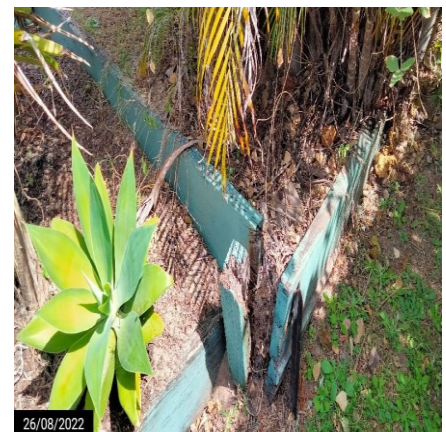
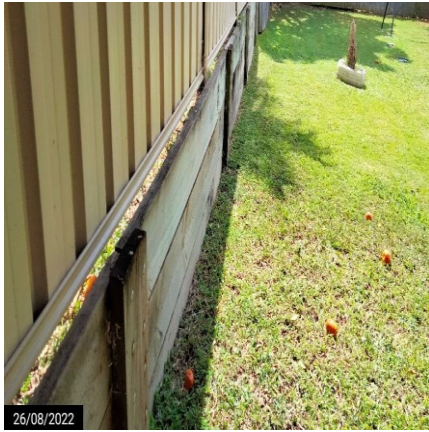
Timber retaining walls

Timber retaining walls are and will continue to deteriorate. Consideration should be given to replacing these walls with a more durable material.

Replace timber showing wood decay with a suitable "h" rated treated pine timber or a suitable exterior product.

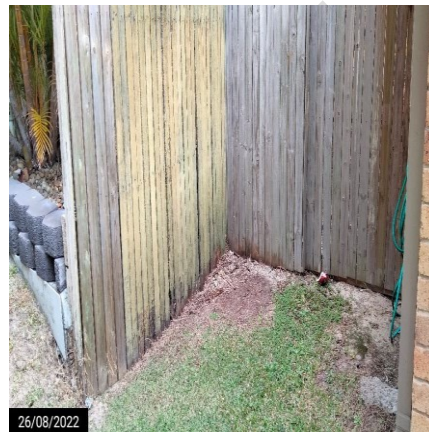
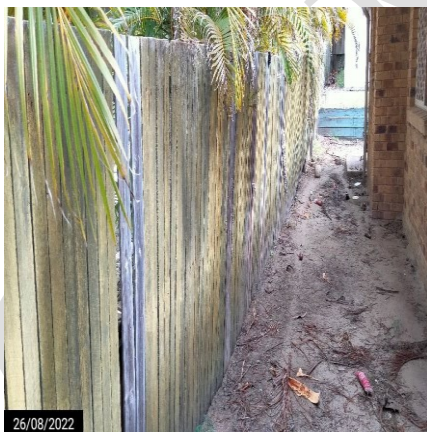
Timber fencing

Untreated or decaying timber decking, fences, retaining walls, loose logs and stumps are always at risk of termite attack/infestation and future activity is likely. Remove where necessary and/or replace with a non-susceptible exterior product.

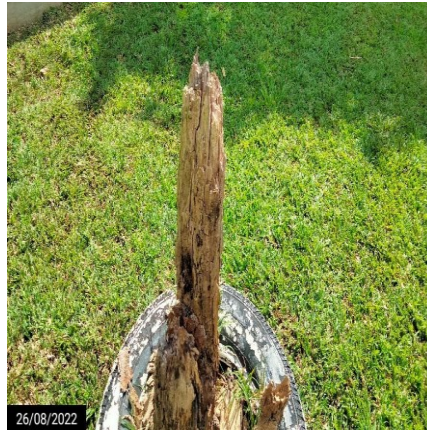
Stump

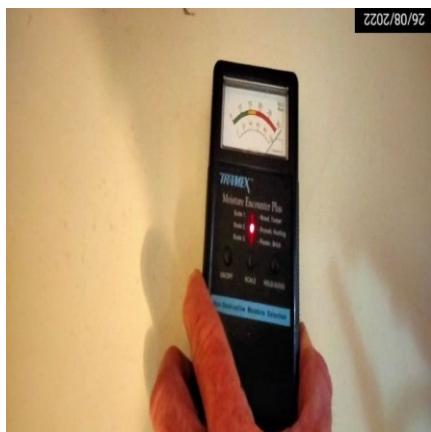
High moisture reading ensuite shower walls

High moisture meter readings to walls surrounding ensuite shower. This may promote termite activity as termites are attracted to moisture. Recommend further investigation by a qualified trades-person to determine the source of the leak and possible solution to repair.

The moisture meter detected that there is excessive moisture to ensuite shower walls further investigation as to the cause of this moisture is strongly recommended.

HIGH MOISTURE RECOMMENDATION; Water leaks, especially in or into the sub-floor or against the external walls, increases the likelihood of termite attack. Leaking showers or high moisture to areas also increase the likelihood of termite attack and fungal decay. See also clause A.5

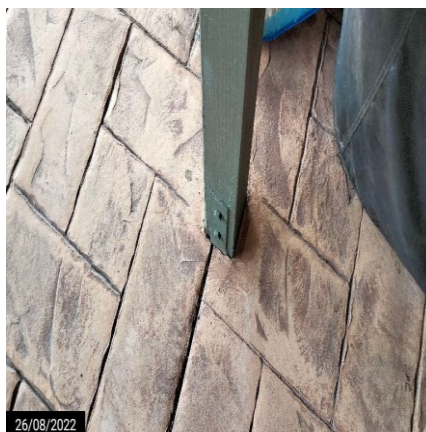
Timber ground contact

Was evidence of untreated or non-durable timber used in a hazardous environment found? **Yes**

Untreated or decaying timber decking, fences, retaining walls, loose logs and stumps are always at risk of termite attack/infestation and future activity is likely. Remove where necessary and/or replace with a non-susceptible exterior product.

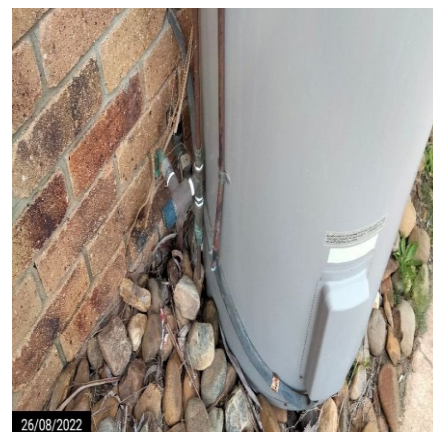
Hot water drain

Hot water system, air-conditioners, taps, defective guttering/downpipes/stormwater drains dispersing water close to the house foundations. Strongly recommend contacting plumber to divert away from the building to drainage or repair.

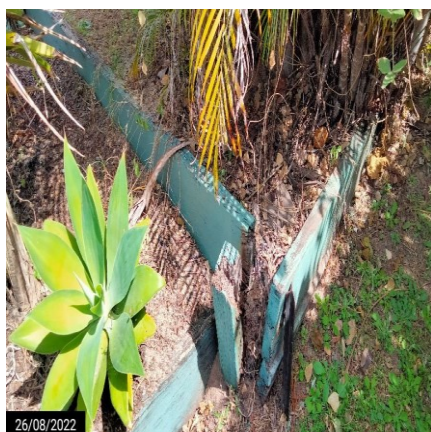
Timber retaining walls

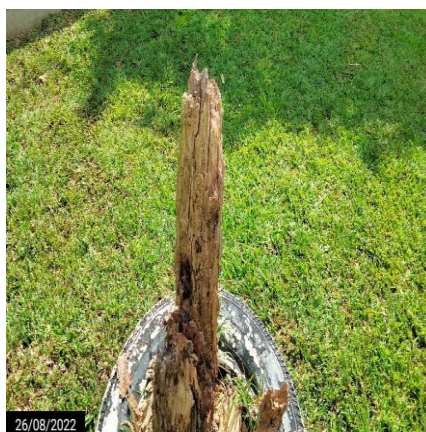
Stump
