CONDITION INSPECTION REPORT

In accordance with AS 4349.0

999 Sea Drive, Main Beach Qld 4217

27 July 2022

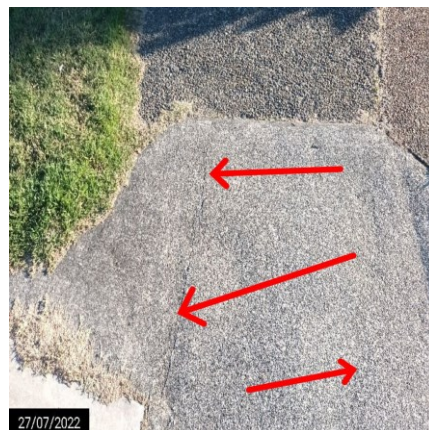
Cracking to concrete footpaths (up to 3mm).

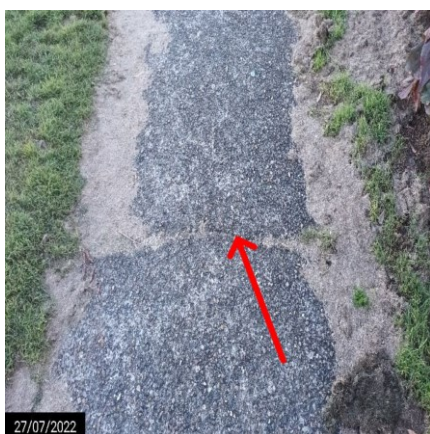
Cracking to concrete footpaths (up to 3mm).

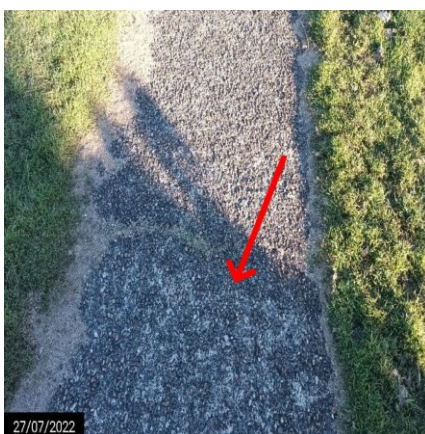
Cracking to concrete footpaths (up to 3mm).

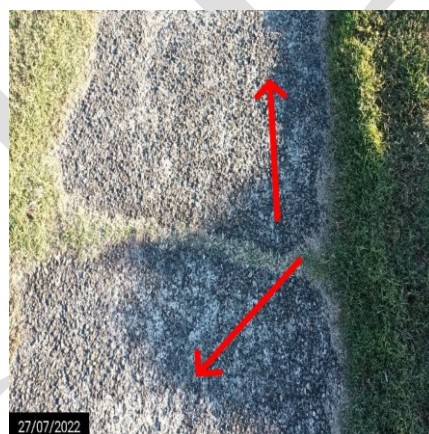
Cracking to concrete footpaths (up to 2mm).

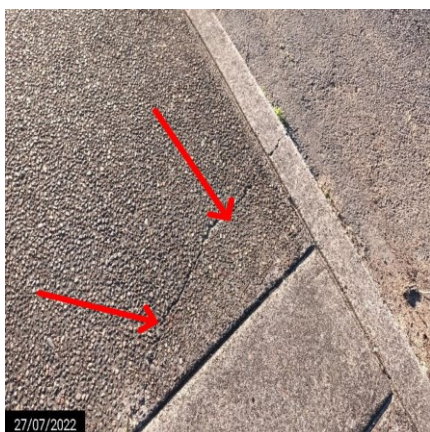
Cracking to concrete footpaths (up to 3mm).

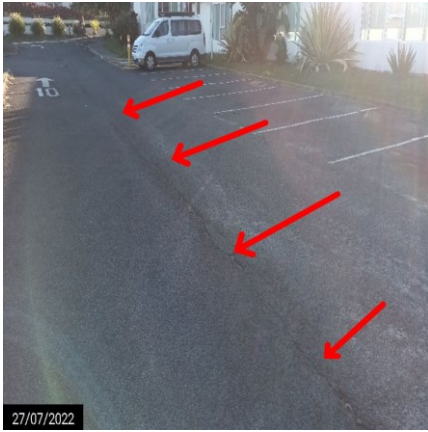
Cracking to carpark roadway (up to 3mm).

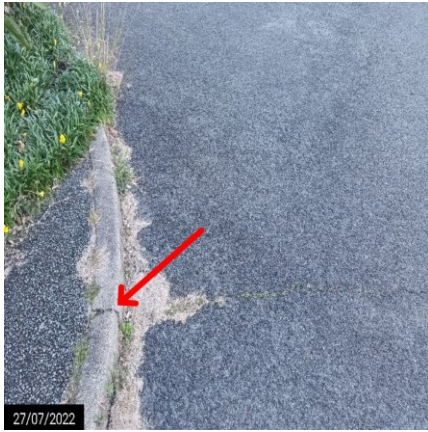
Cracking to concrete kerb (up to 3mm).

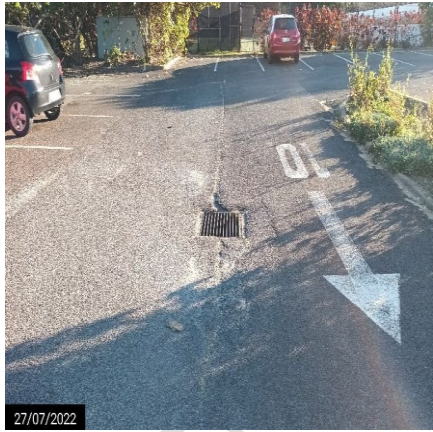
Movement/ cracking to carparking roadway (up to 8mm).

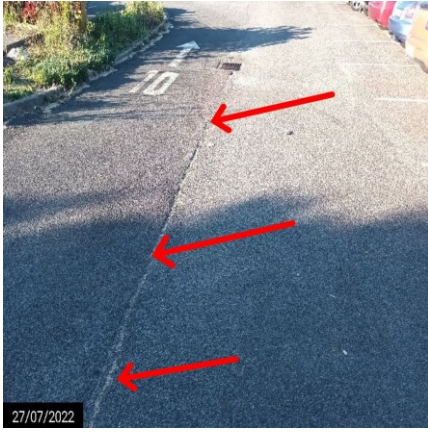
Movement/ cracking to carparking roadway (up to 8mm).

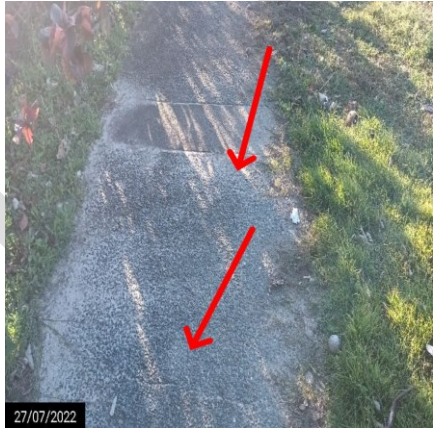
Cracking to concrete pathways south of tennis court (up to 2mm).

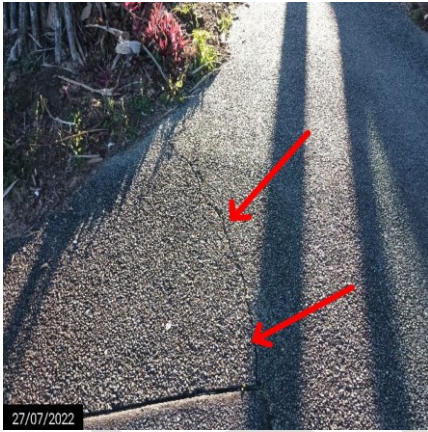
Cracking to concrete pathways south of tennis court (up to 2mm).

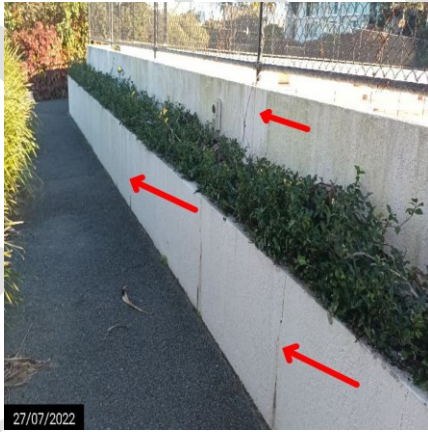
Cracking to tennis court retaining wall along south elevation (up to 2mm).

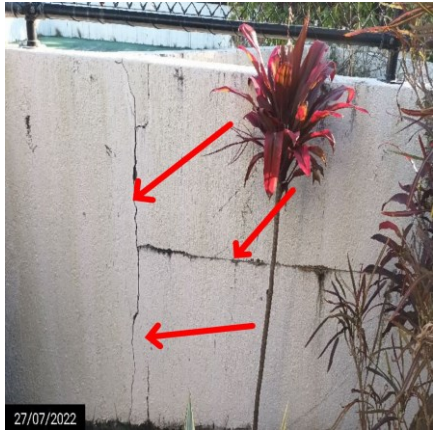
Cracking to tennis court retaining wall along south east corner (up to 2mm).

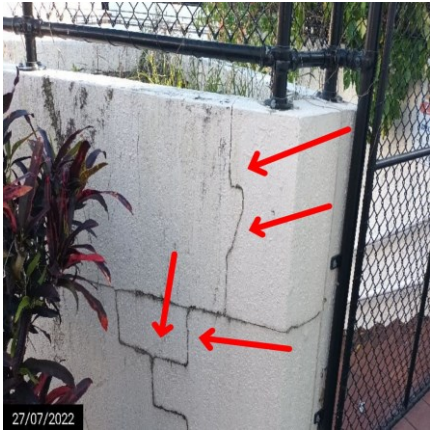
Cracking to tennis court retaining wall along south east corner (up to 2mm).

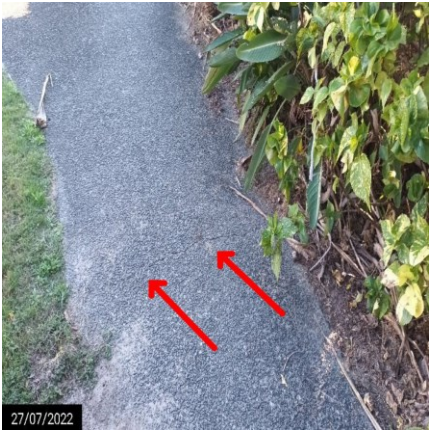
Cracking to concrete pathways along south elevation of tennis court (up to 2mm).

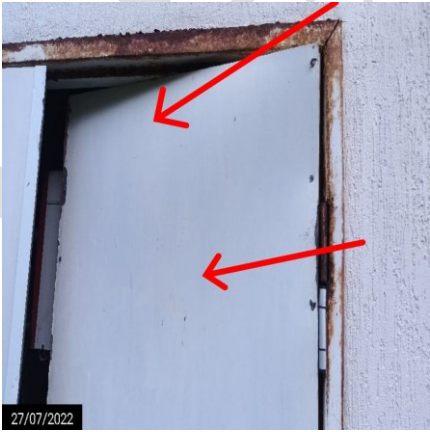
Damaged door to east elevation storage cupboard.

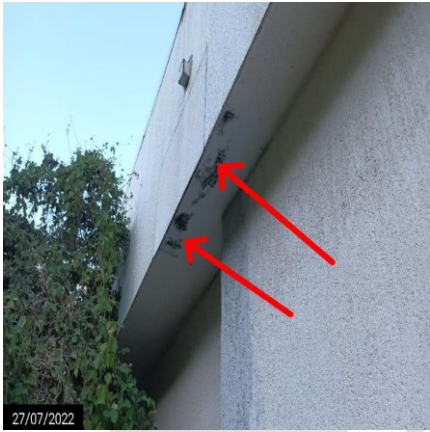
Moisture staining to east elevation.

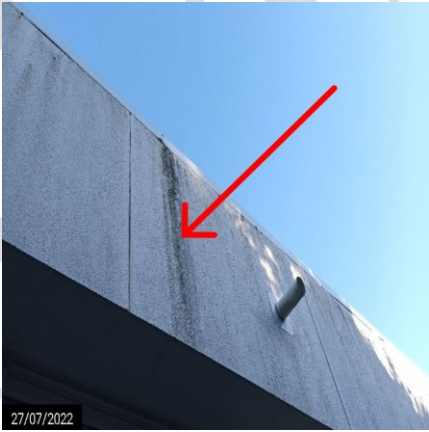
Moisture staining to east elevation.

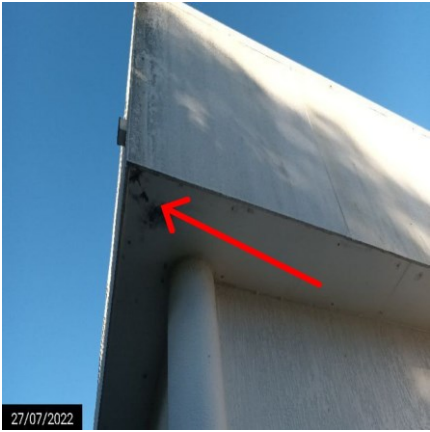
Moisture staining to east elevation eaves linings.

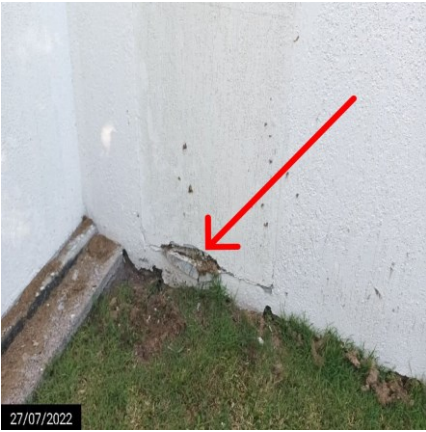
Cracking to masonry walls along east wall.

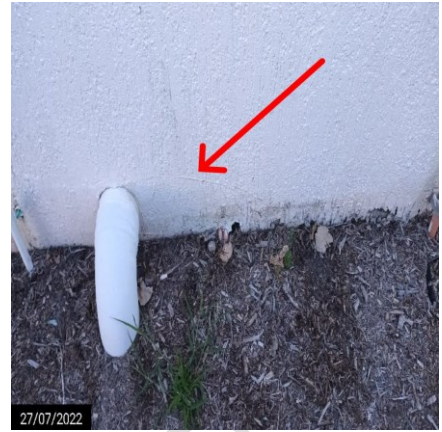
Cracking to west elevation masonry wall (up to 2mm).

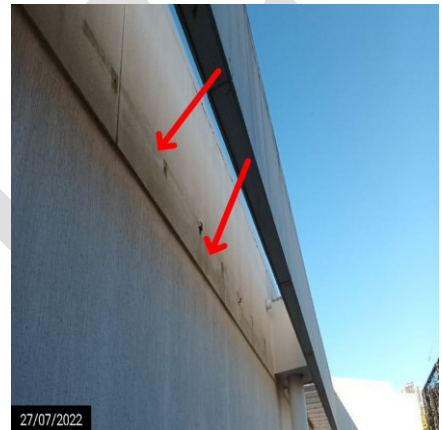
Eave timber feature trellis along west adjacent tennis court missing.

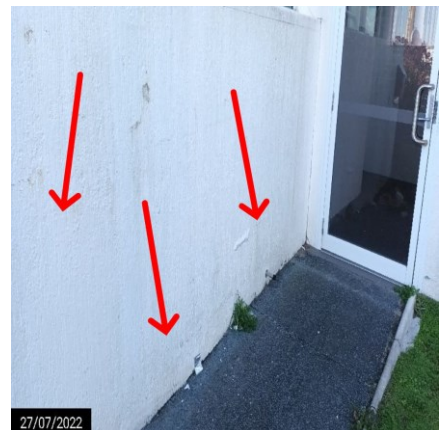
Cracking to tennis south elevation wall linings (up to 3mm).

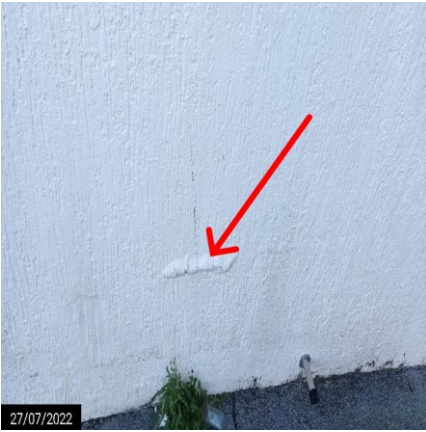
Efflorescence to south elevation masonry wall adjacent car park near disabled park.

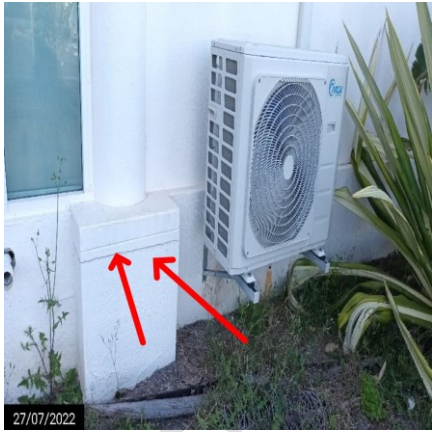
Cracking to wall lining along west elevation (up to 2mm).

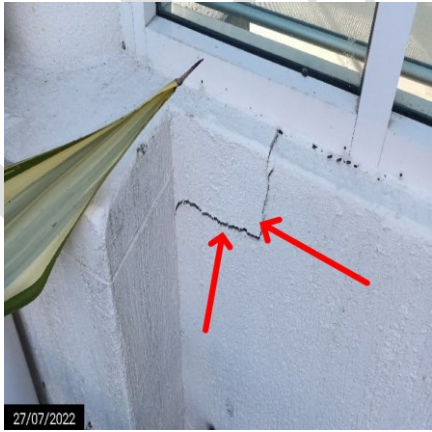
Cracking to west elevation wall linings (up to 4mm).

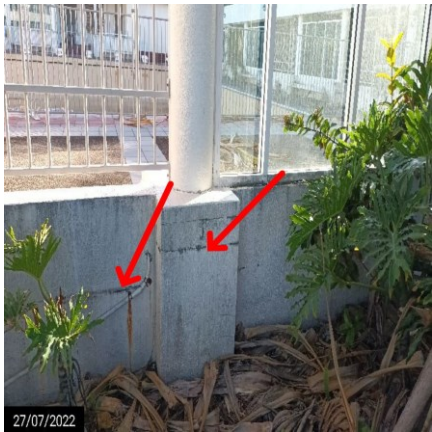
Cracking to pool south elevation wall linings (up to 3mm).

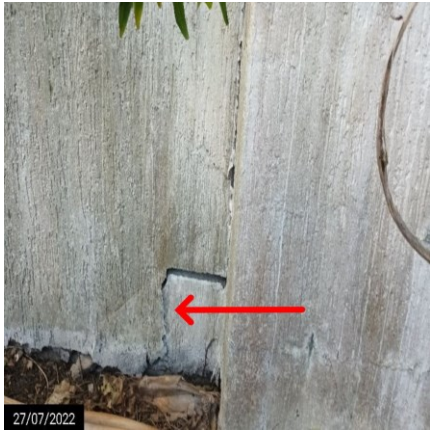
Cracking to pool south elevation wall linings (up to 3mm).

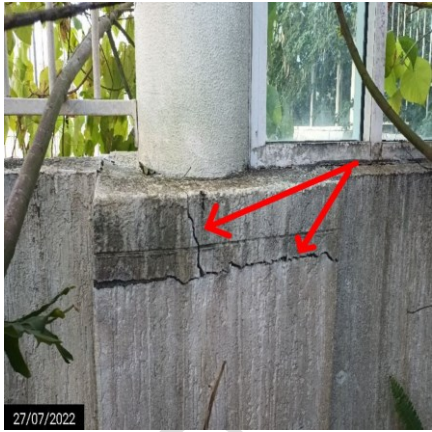
Cracking to retaining walls along pool courts along south end (up to 2mm).

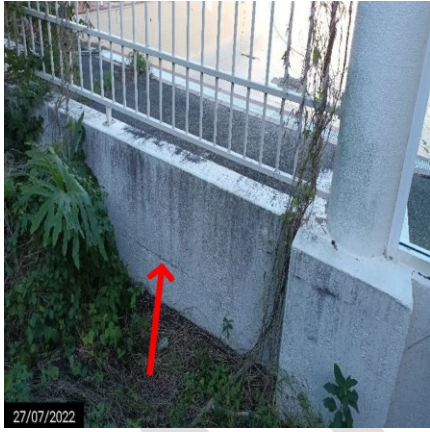
Cracking to retaining walls along pool south end (up to 2mm).

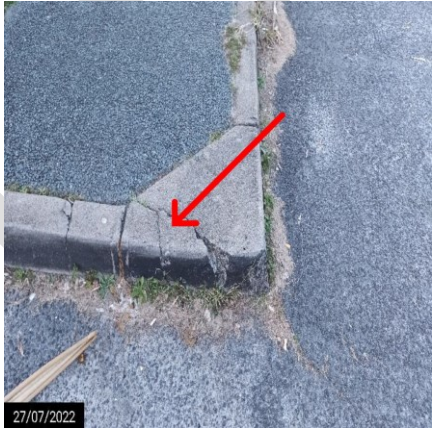
Cracking/ movement to concrete kerb along road ways (up to 2mm).

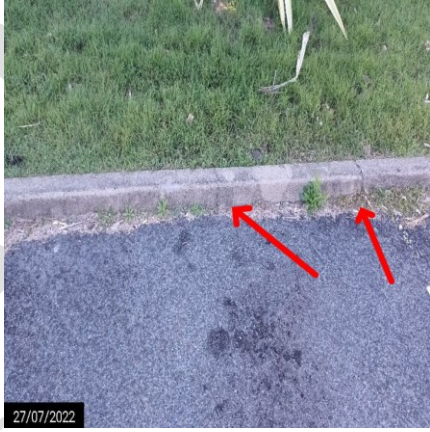
Cracking/ movement to concrete kerb along road ways (up to 2mm).

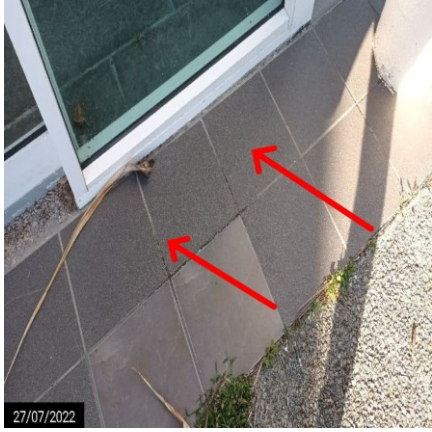
Drummy tiles along external entry tiles.

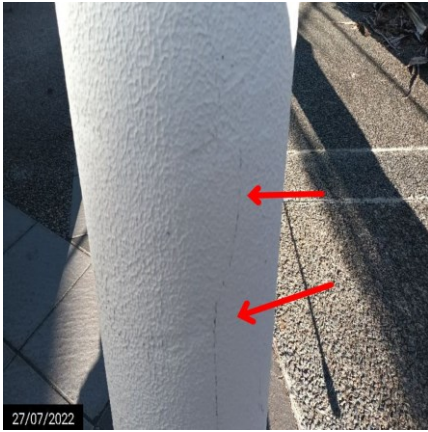
Cracking to concrete column along entry elevation (up to 2mm).

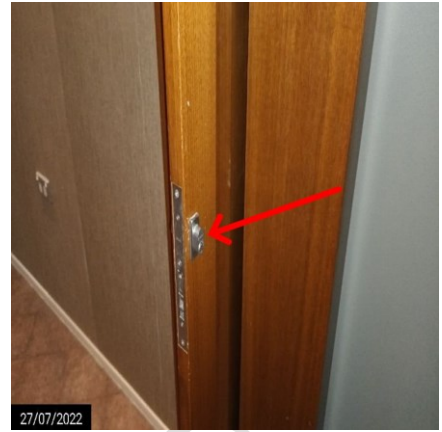
Doors require adjustment.

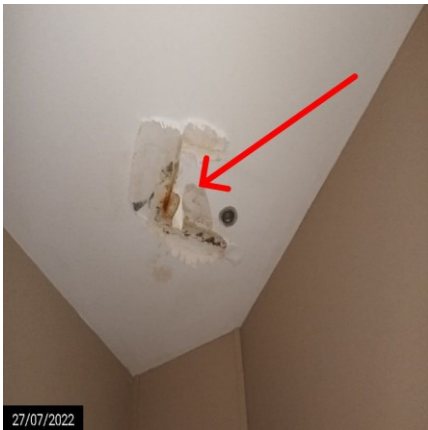
Moisture staining to plaster ceiling linings (treatment room 1).

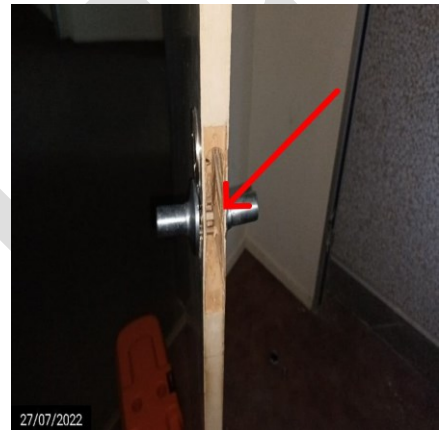
Door lock missing from treatment room 1.

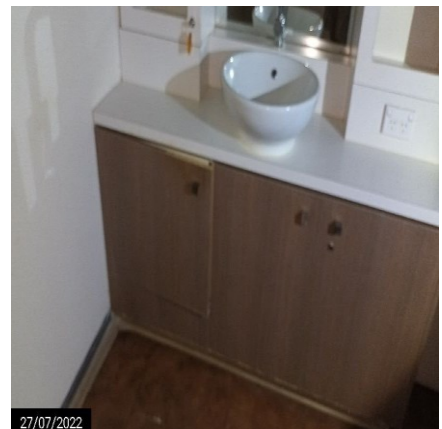
Cupboards to treatment rooms require adjustment.

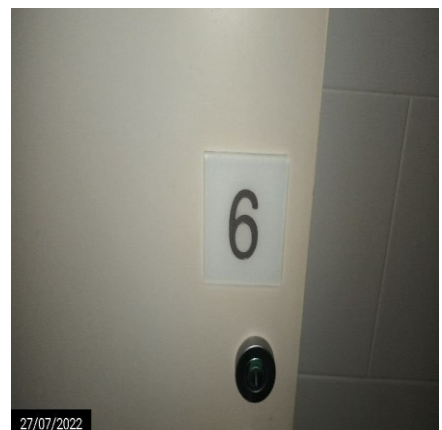
Room 6.

Missing air conditioning ceiling register (6).

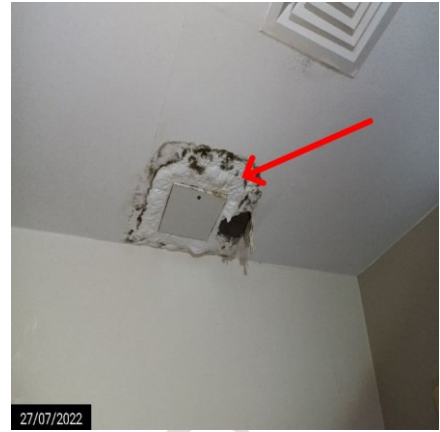
Moisture staining to room 9 plaster ceiling linings.

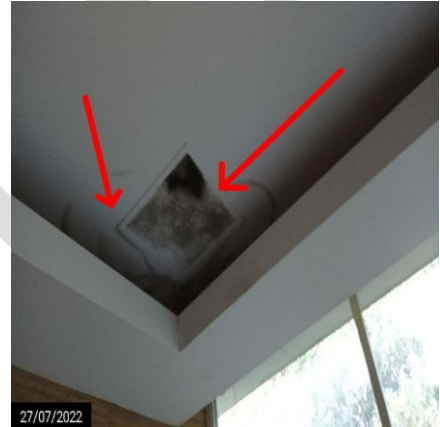
Moisture staining to treatment room lounge plaster ceiling linings.

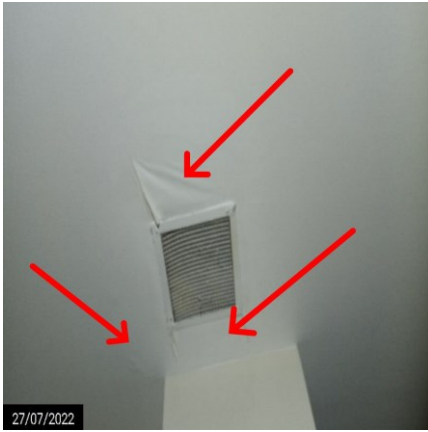
Moisture staining to ladies plaster ceiling linings.

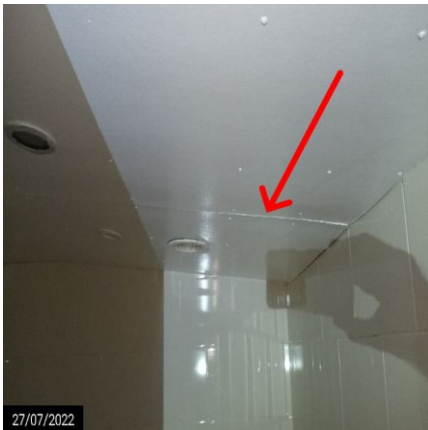
Cracking to ladies plaster ceiling linings (up to 2mm).

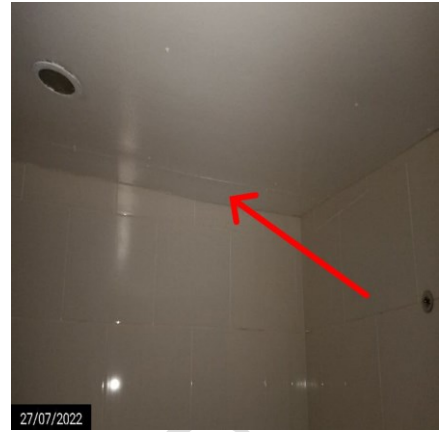
Plaster cracking to male toilet plaster ceiling linings (up to 2mm).

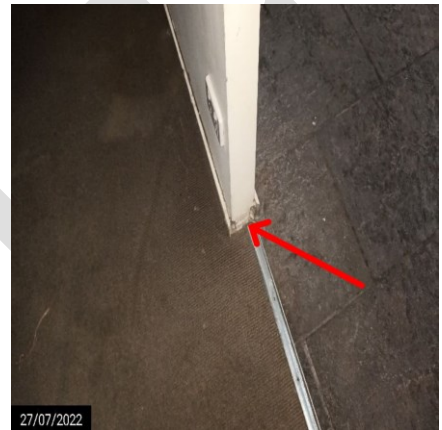
Damaged timber skirtings in reception areas.

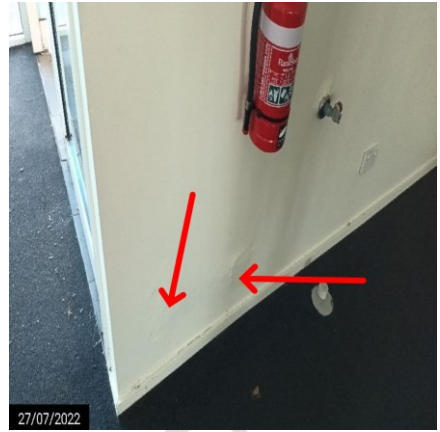
Moisture staining to reception area plaster wall linings (below fire extinguisher).

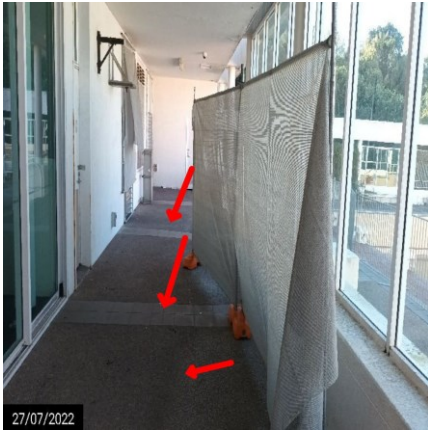
Cracking to concrete pathways (up to 2mm).

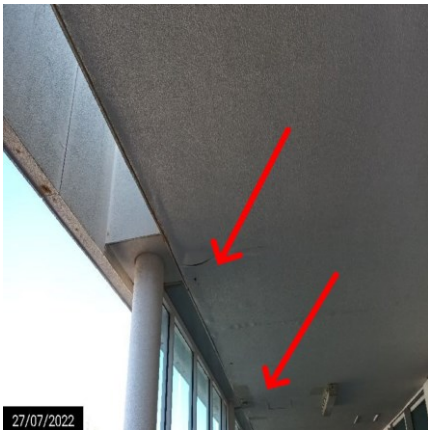
Moisture staining to north end pool verandah.

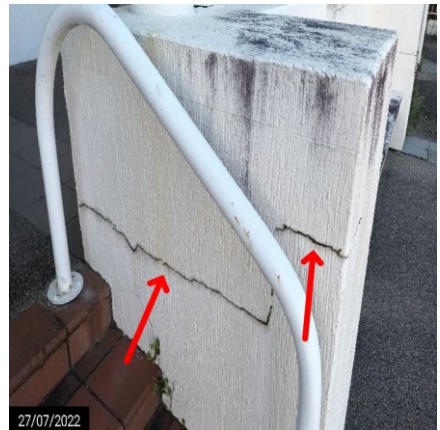
Cracking to masonry walls along north end of pool area (up to 3mm).

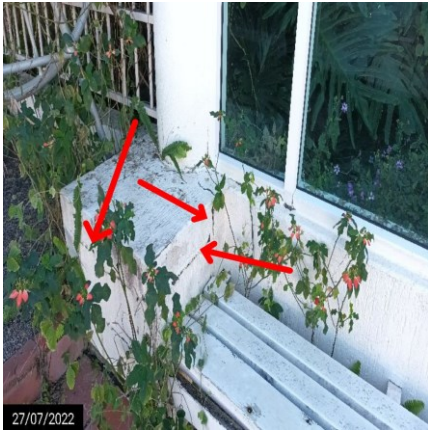
Cracking to concrete bases along pool area (up to 3mm).

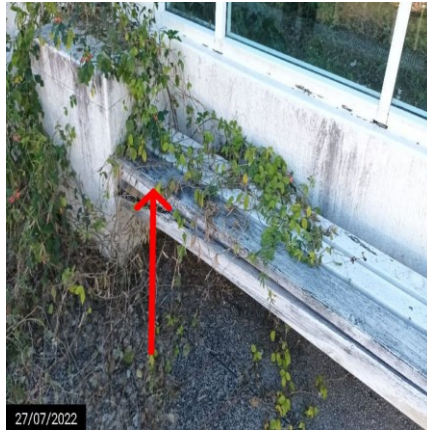
Damaged and decayed pool seating timbers.

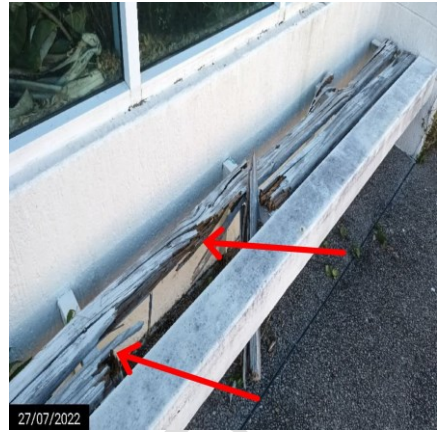
Damaged and decayed pool seating timbers.

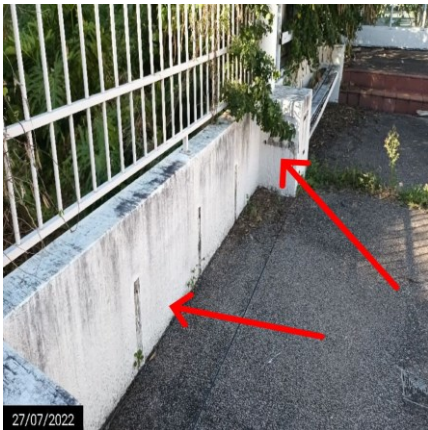
Pool seating missing.

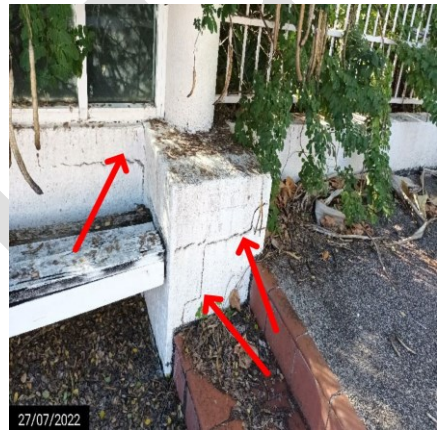
Cracking to concrete bases along pool area (up to 3mm).

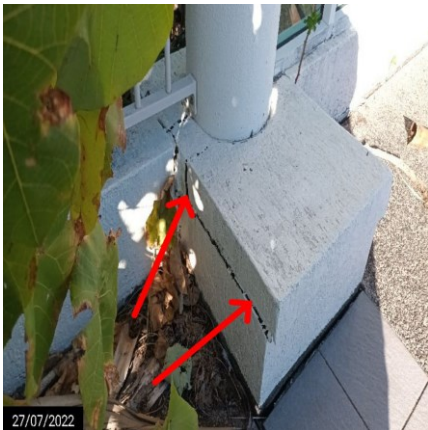
Cracking to concrete bases along pool area (up to 3mm).

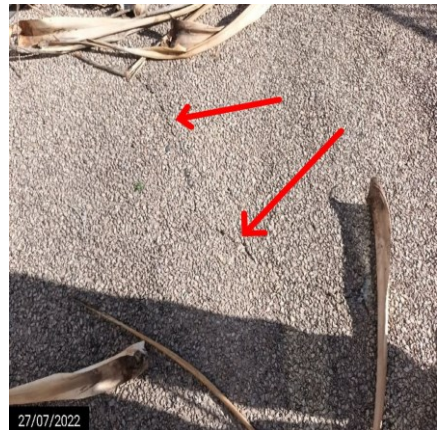
Cracking to concrete pathways along south end of pool area (up to 3mm).

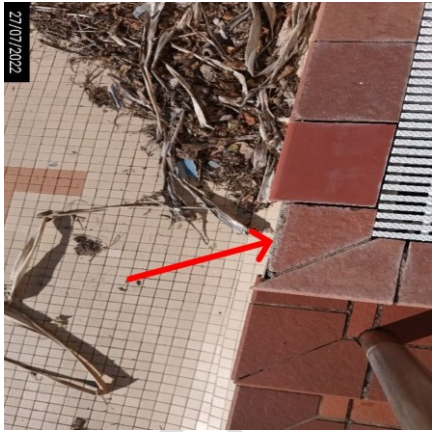
Damaged and loose capping tiles to south west corner of pool shell.

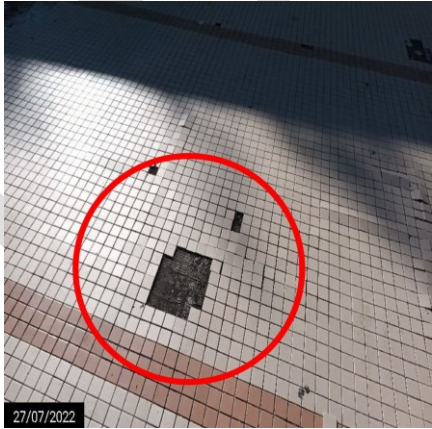
Damaged pool tiling.

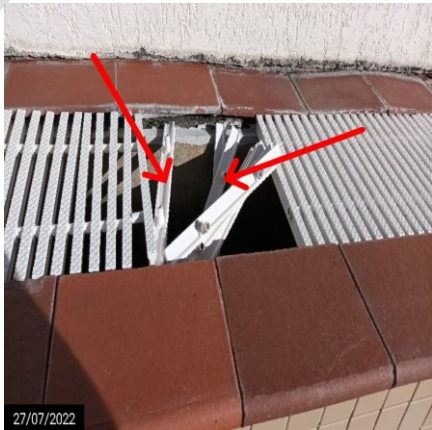
Damaged pool drainage covers.

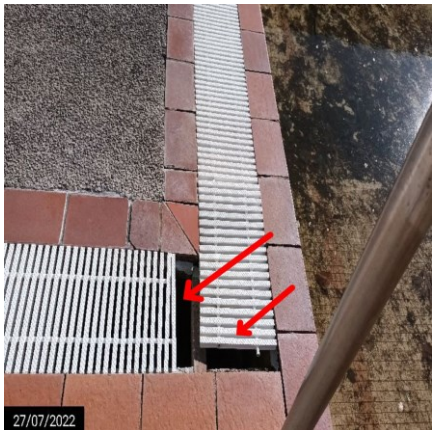
Damaged pool area drain covers.

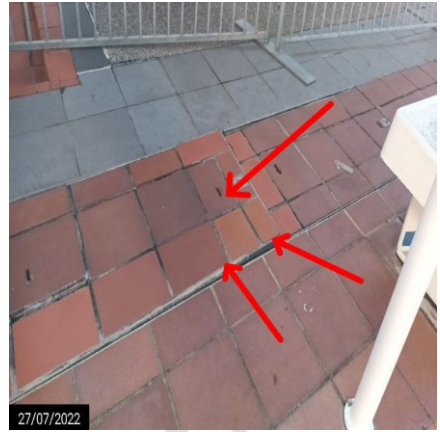
Pool paving pit lid lifting.

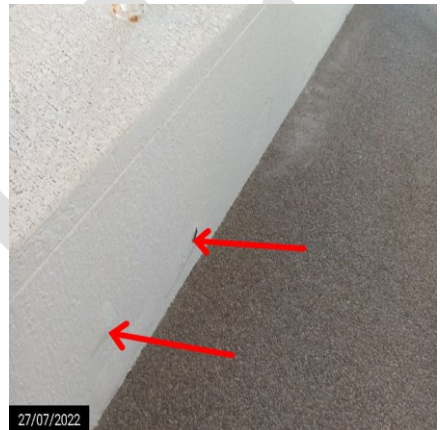
Paint bubbling to masonry walls down access ramp.

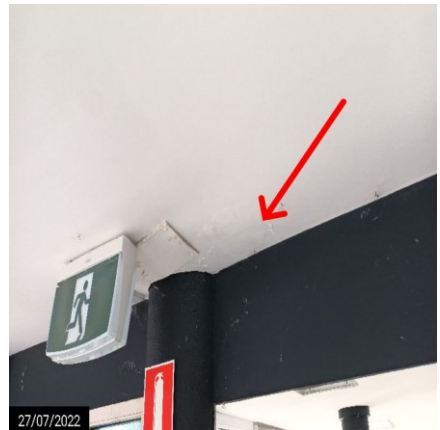
Moisture staining to activity 2 room 1 plaster ceiling linings.

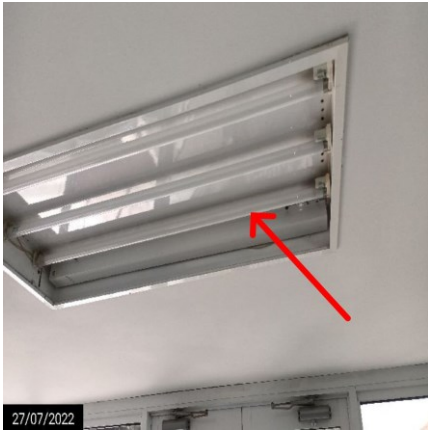
Light cover missing to activity 2 room
along pool.
