ASBESTOS INSPECTION REPORT

2 Day Drive, Burleigh Heads Qld 4220

1 November 2022

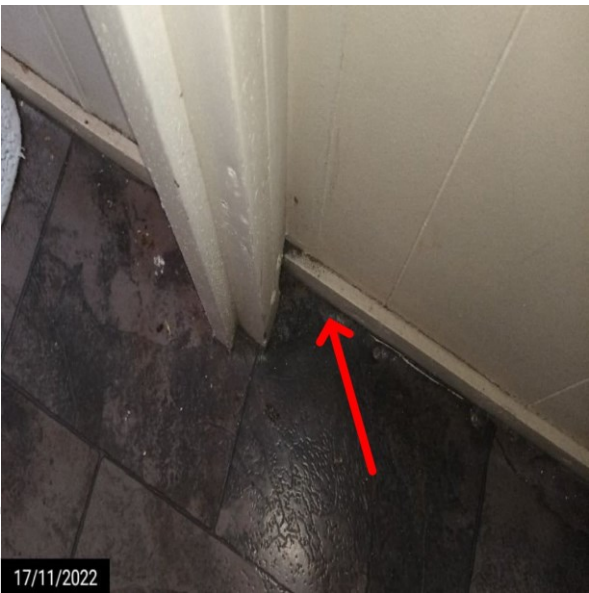
Item #1

Types and Forms of Asbestos Products/Material	Sample Taken	Sample No	Similar To	Asbestos Type	Condition	Priority
Flat Sheet (vinyl)	Yes	1			Good	Low
Location/Notes	Office 2 floor coverings.

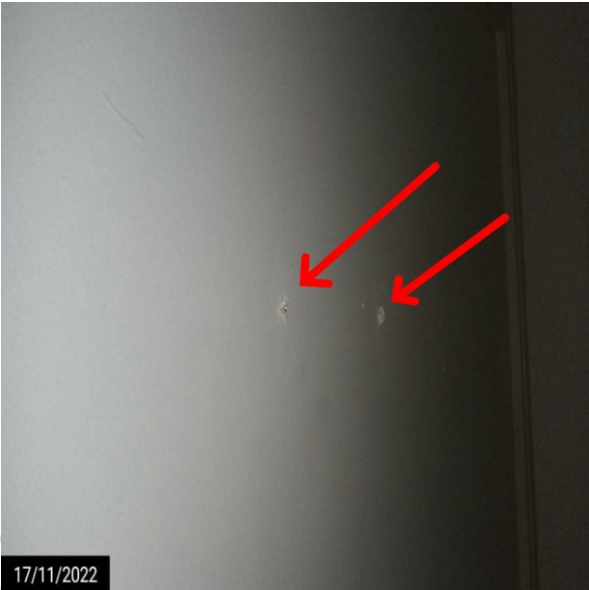
Item #2

Types and Forms of Asbestos Products/Material	Sample Taken	Sample No	Similar To	Asbestos Type	Condition	Priority
Flat Sheet	Yes	2			Good	Low
Location/Notes	Main Office WC wall linings.

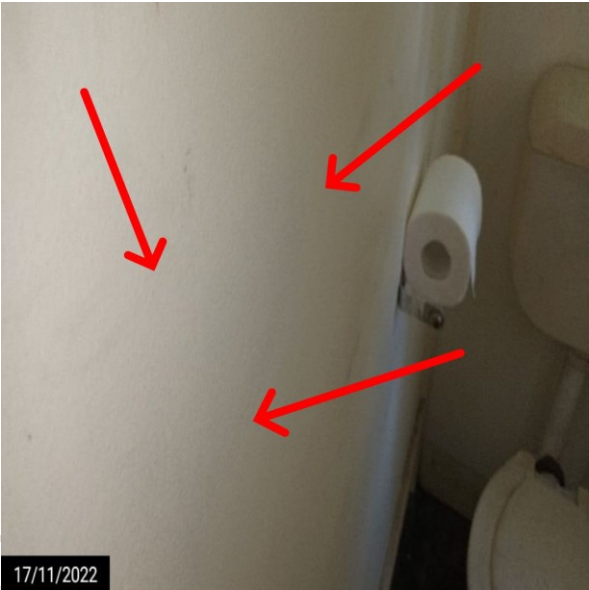
Item #3

Types and Forms of Asbestos Products/Material	Sample Taken	Sample No	Similar To	Asbestos Type	Condition	Priority
Flat Sheet	No		2		Good	Low
Location/Notes	Main Office WC wall linings.

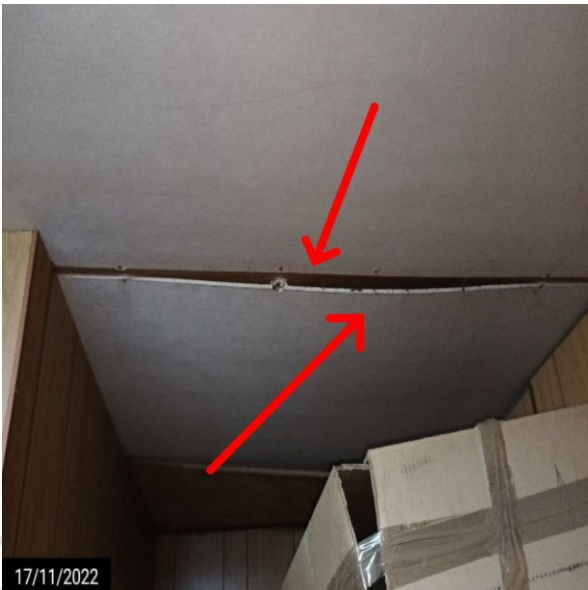
Item #4

Types and Forms of Asbestos Products/Material	Sample Taken	Sample No	Similar To	Asbestos Type	Condition	Priority
Flat Sheet	Yes	3			Good	Low
Location/Notes	Main factory rear office ceiling linings.					
<div>

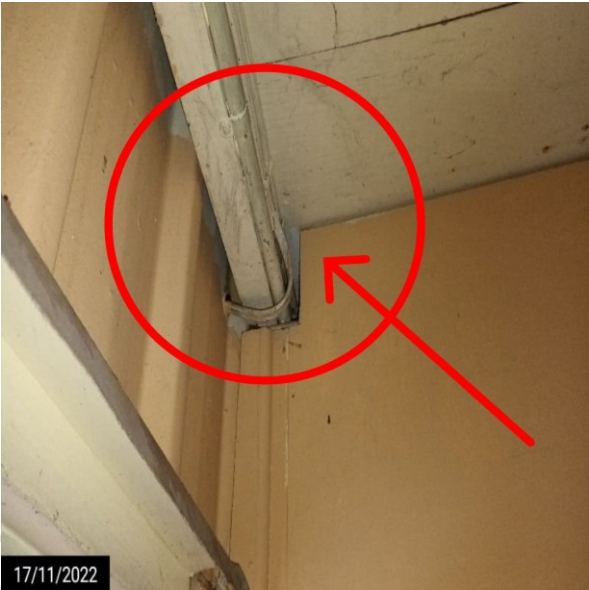
Item #5

Types and Forms of Asbestos Products/Material	Sample Taken	Sample No	Similar To	Asbestos Type	Condition	Priority
Flat Sheet	Yes	4			Good	Low
Location/Notes	Main factory WC wall linings.

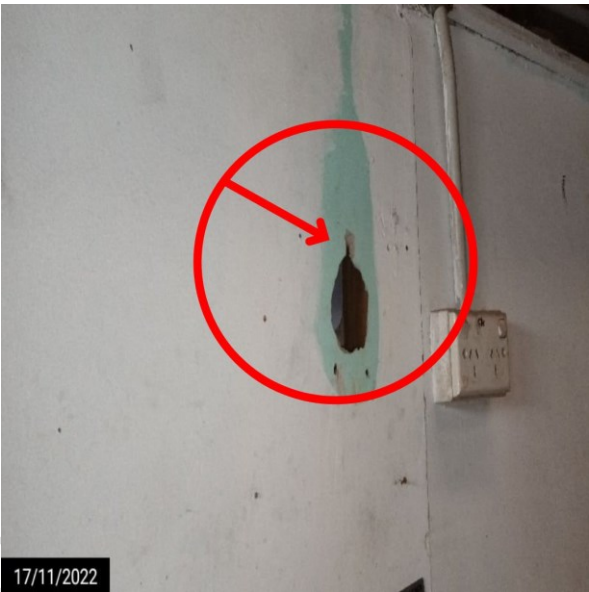
Item #6

Types and Forms of Asbestos Products/Material	Sample Taken	Sample No	Similar To	Asbestos Type	Condition	Priority
Flat Sheet	Yes	5			Good	Low
Location/Notes	Internal storeroom wall linings.

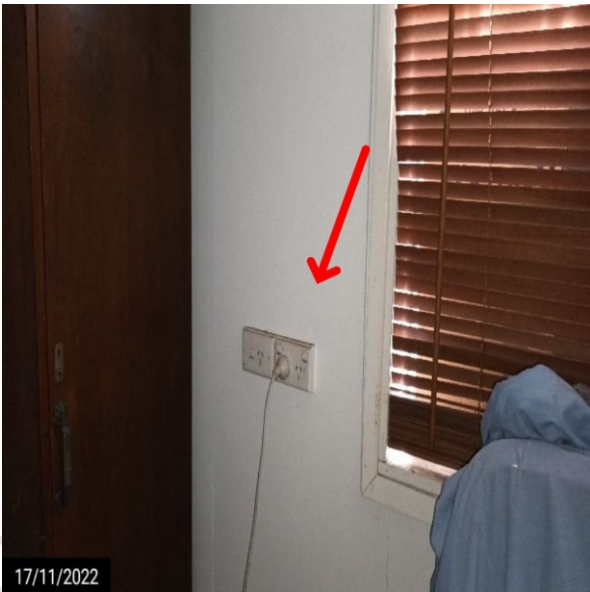
Item #7

Types and Forms of Asbestos Products/Material	Sample Taken	Sample No	Similar To	Asbestos Type	Condition	Priority
Flat Sheet			5		Good	Low
Location/Notes	Internal office (inside factory) wall linings.

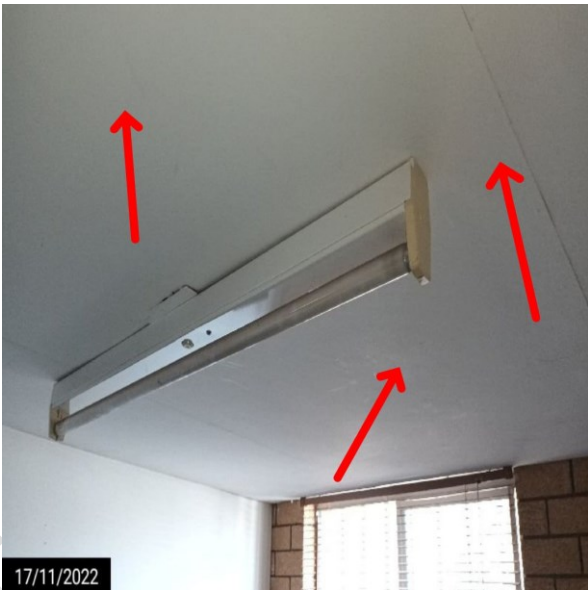
Item #8

Types and Forms of Asbestos Products/Material	Sample Taken	Sample No	Similar To	Asbestos Type	Condition	Priority
Flat Sheet	No		5		Good	Low
Location/Notes	Internal office (inside factory) ceiling linings.

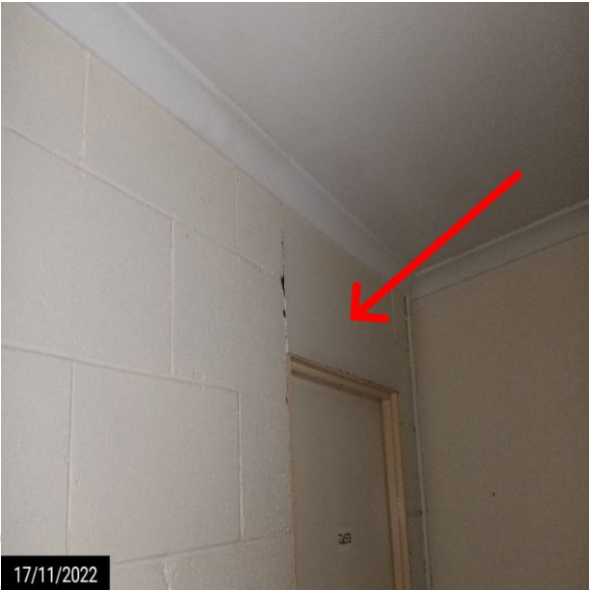
Item #9

Types and Forms of Asbestos Products/Material	Sample Taken	Sample No	Similar To	Asbestos Type	Condition	Priority
Flat Sheet	No		5		Good	Low
Location/Notes	Main office WC wall lining above door
