CONDITION INSPECTION REPORT

1 (Lot 307) Home Place, Bushland Beach QLD 4818

17 June 2022

This is a Handover Report as requested by the client for a new property.

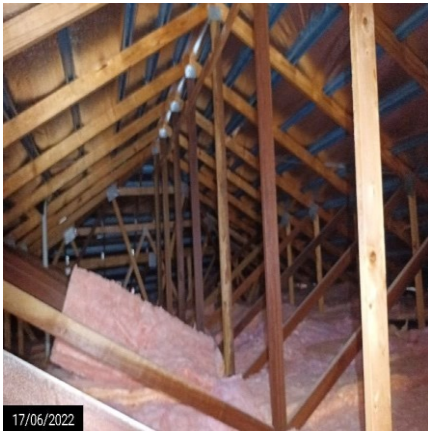
Roof void.

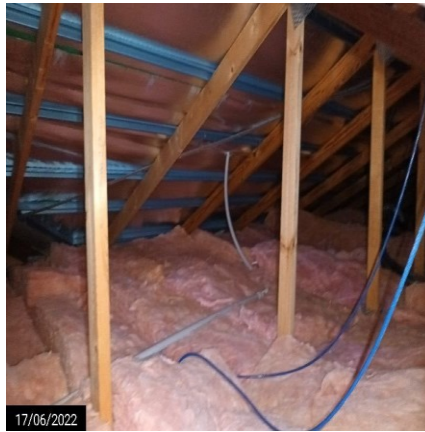
Roof void.

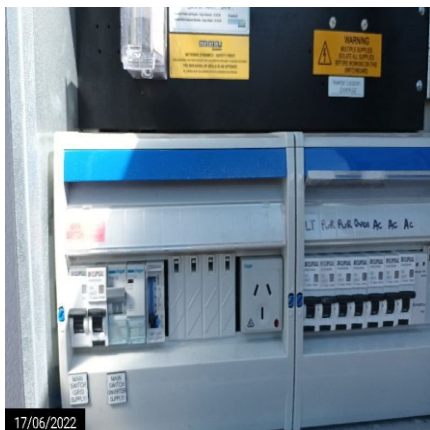
Electrical safety switch installed.

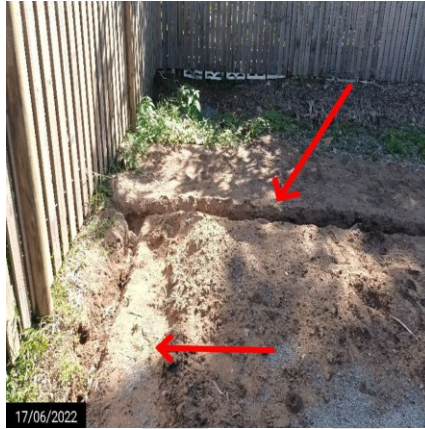
Landscaping incomplete.

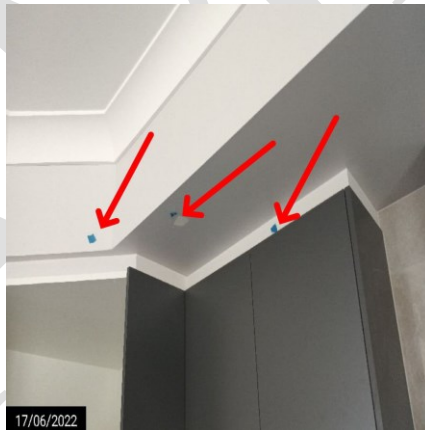
Marks to paint kitchen overhead cupboard bulkhead (consistent to kitchen area).

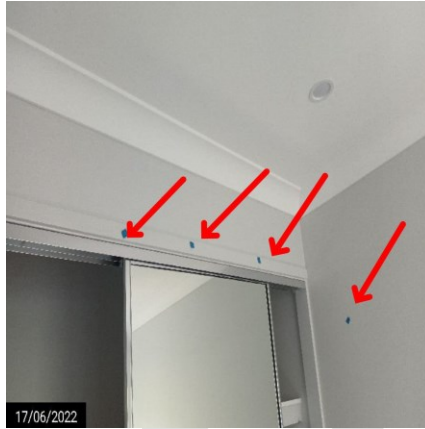
Marks to bedroom 3 robe architraves and walls.

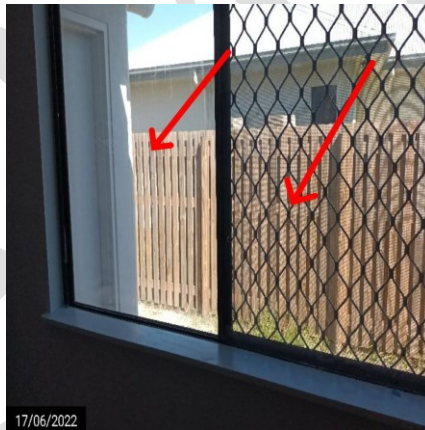
Builders clean incomplete (window glazing).

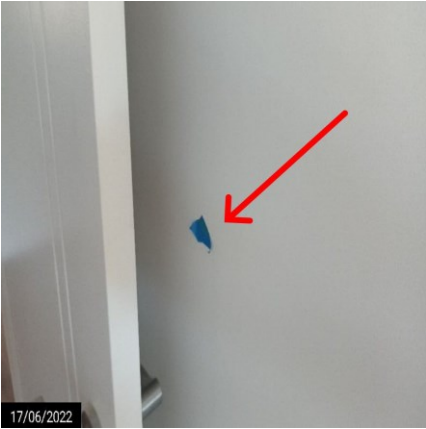
Mark to bedroom 4 plaster wall lining behind door.

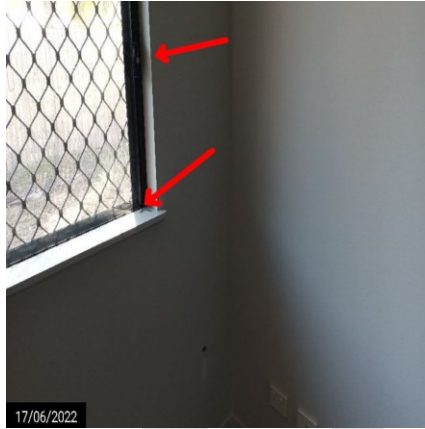
Poor paint finish around window frames.

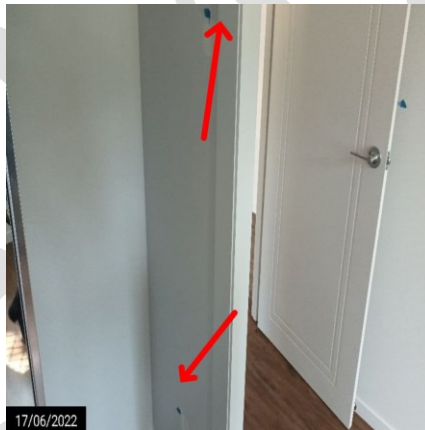
Marks to plaster wall linings inside bedroom 4 robe.
