CONDITION INSPECTION REPORT

In accordance with AS 4349.0

999 Sea Drive, Main Beach Qld 4217

27 July 2022

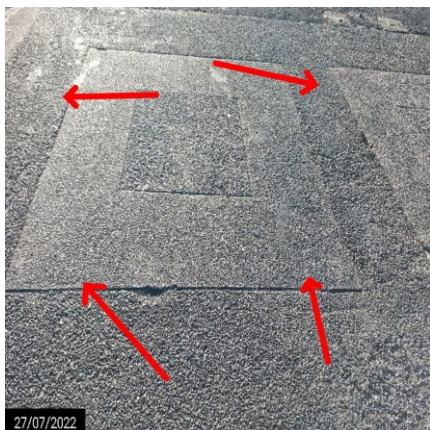
Repairs to roadway near roundabout entry.

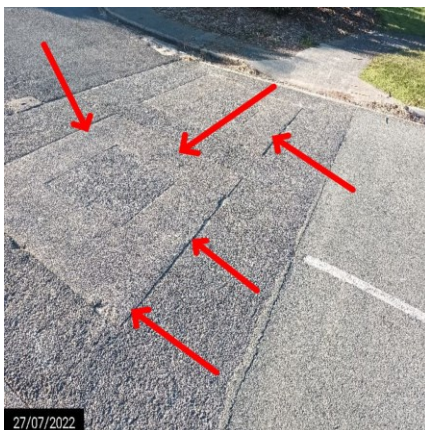
Repairs to roadway near roundabout entry.

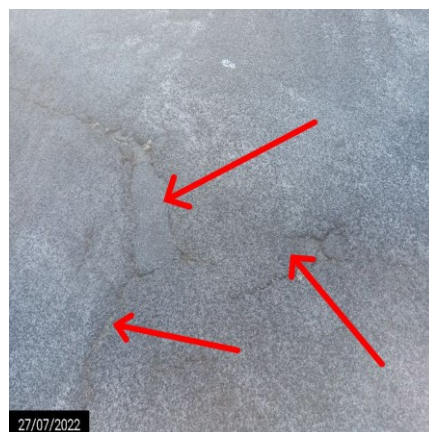
Movement/ lifting of bitumen roadway.

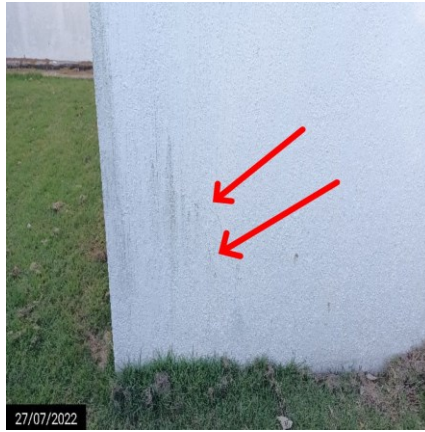
Cracking to masonry walls along north east corner (up to 2mm).

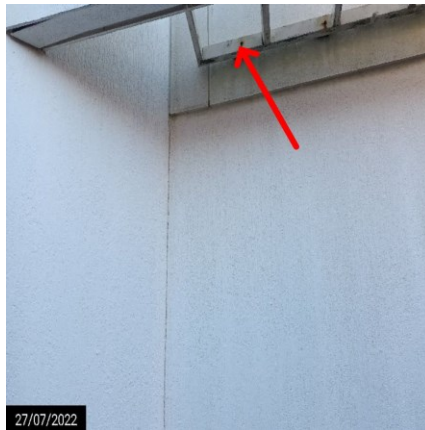
Eave trellis along west adjacent tennis course deteriorated.

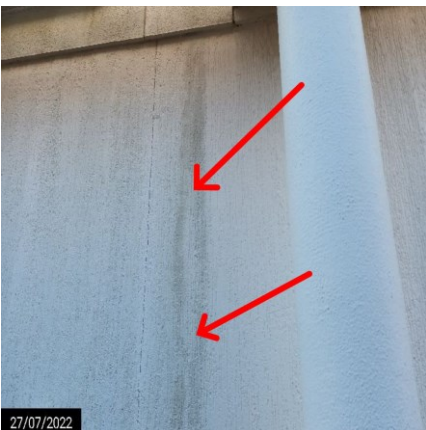
Moisture staining to west elevation near entry.

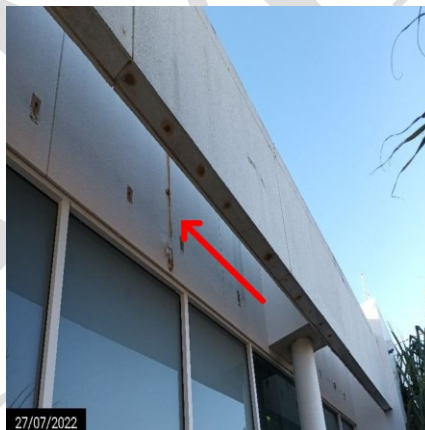
Moisture staining to west elevation near entry.

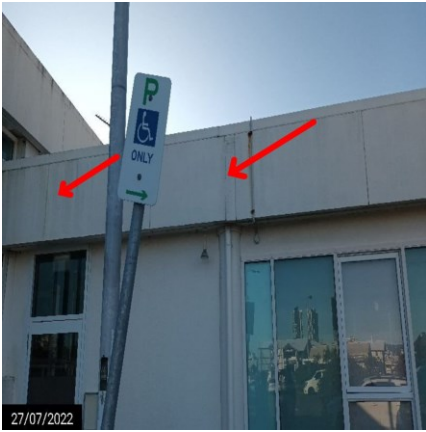
Movement to West elevation roof parapet.

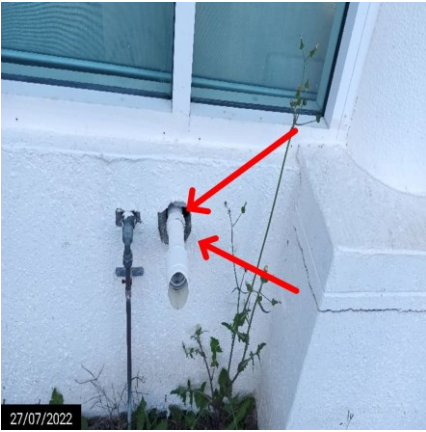
Hole in wall lining at waste pipe along west elevation.

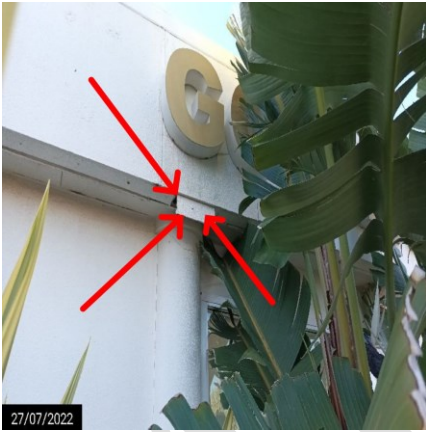
Damaged eave along west elevation.

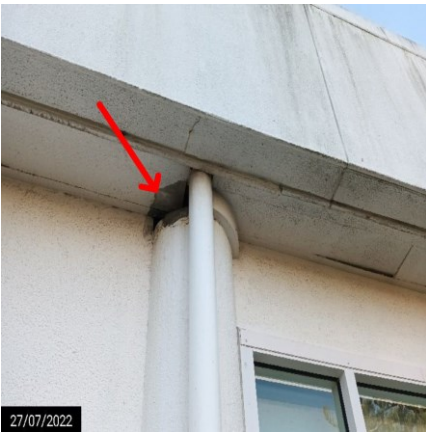
Damaged column eaves cover.

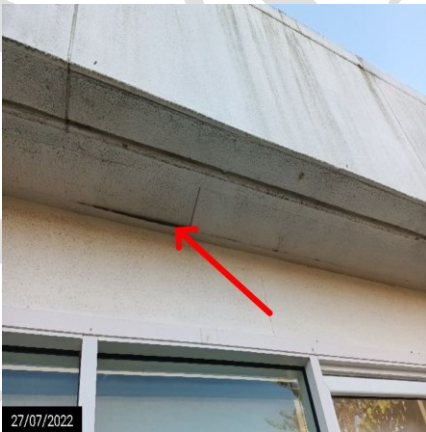
Movement to eaves lining elevation along west elevation.

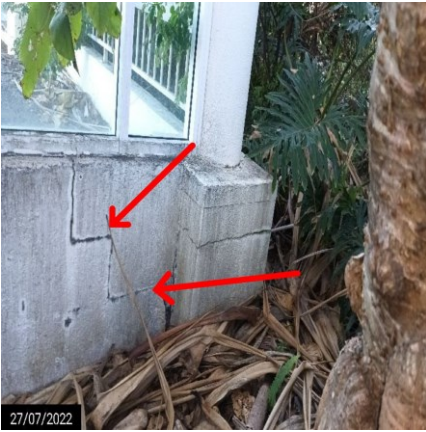
Cracking to pool south/east elevation wall linings (up to 3mm).

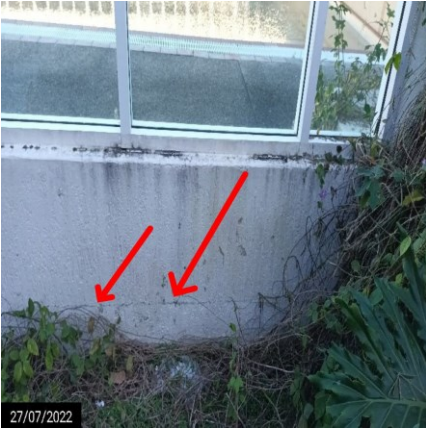
Cracking to retaining walls along pool south end (up to 2mm).

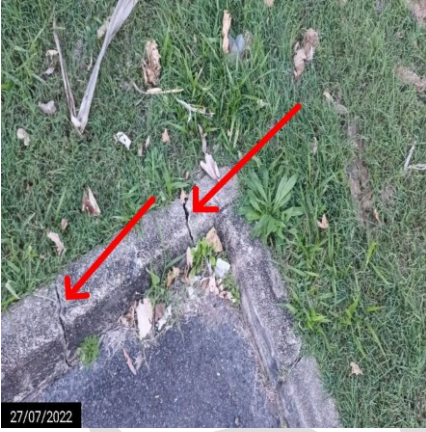
Cracking/ movement to concrete kerb along road ways (up to 2mm).

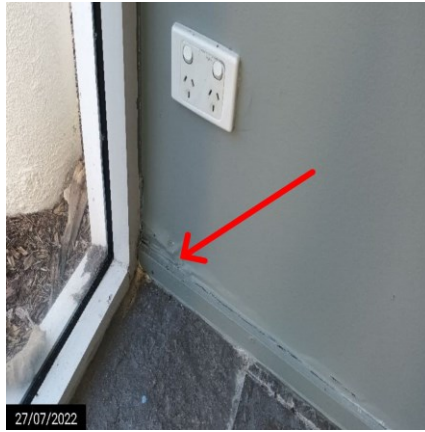
Moisture staining to reception area north elevation.

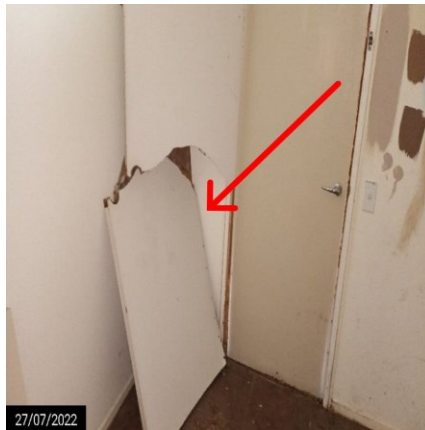
Exit door damaged (treatment room).

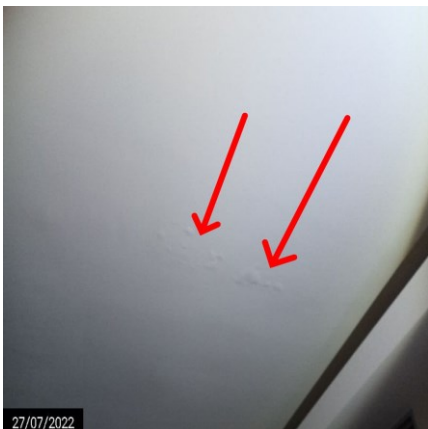
Moisture staining to treatment room 2.

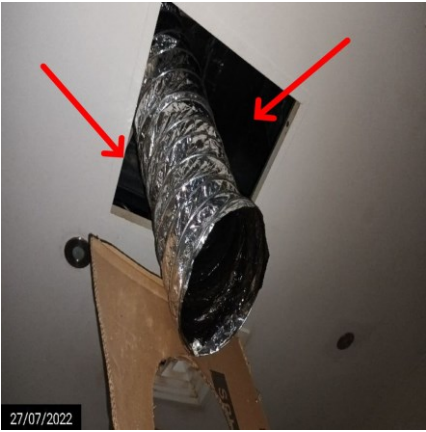
Missing air conditioning ceiling register (6).

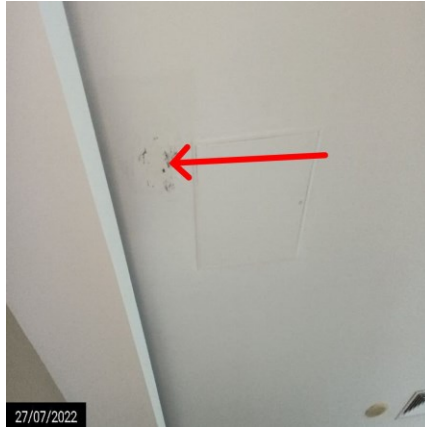
Moisture staining to treatment room lounge plaster ceiling linings.

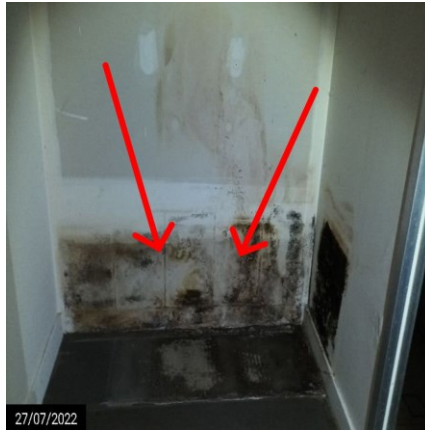
Evidence of mould to ladies toilet.

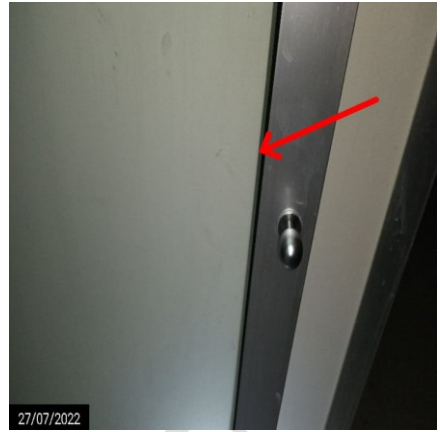
Some doors require adjustment.

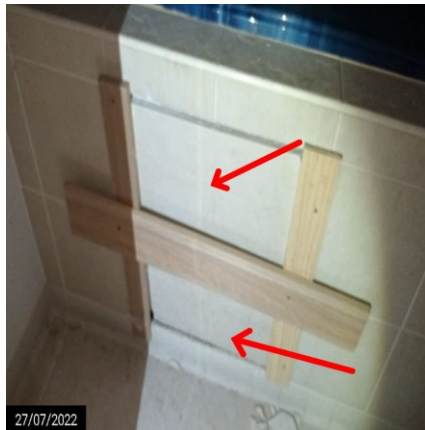
Loose ladies spa pump access.

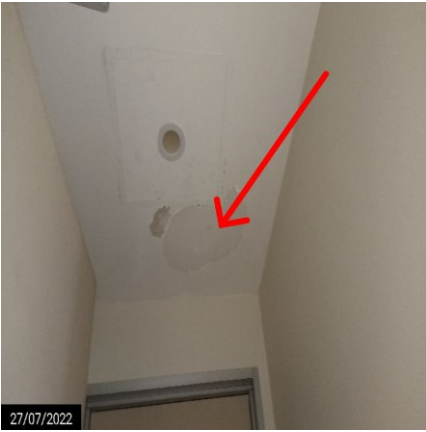
Moisture staining to male plaster ceiling linings.

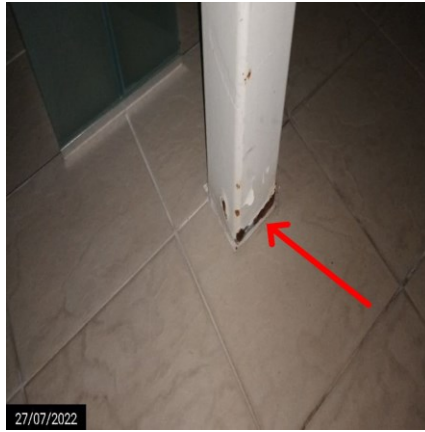
Rust to male toilet steel post.

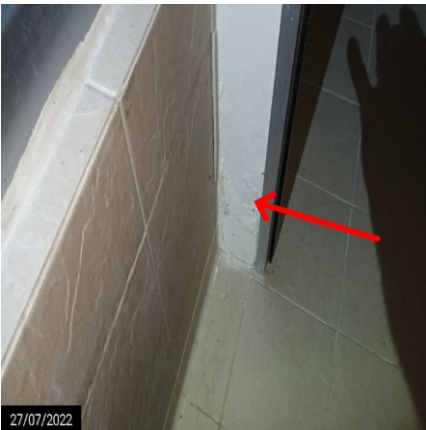
Moisture staining to reception area.

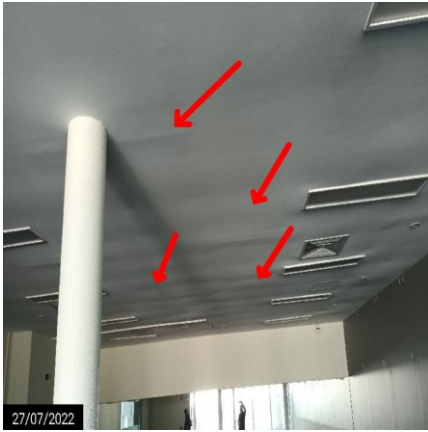
Minor sagging to activity 1 plaster ceiling linings (up to 5mm).

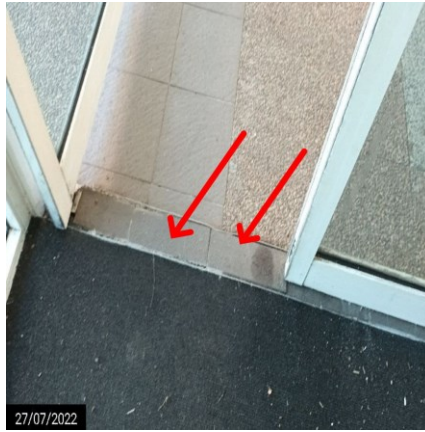
Drummy floor tiles to activity 1 door opening.

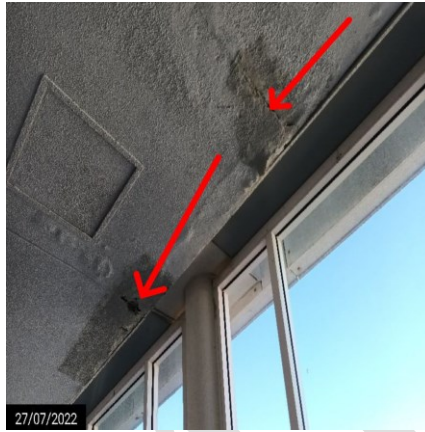
Moisture staining to north end pool verandah.

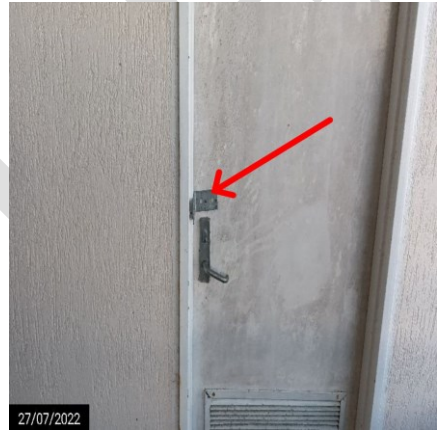
Locked access door.

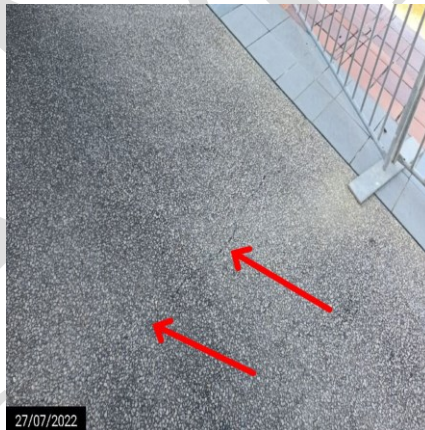
Cracking to concrete pathways around pool areas (up to 2mm).

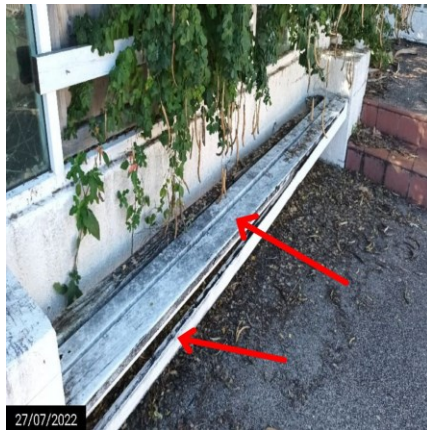
Damaged and decayed pool seating timbers.

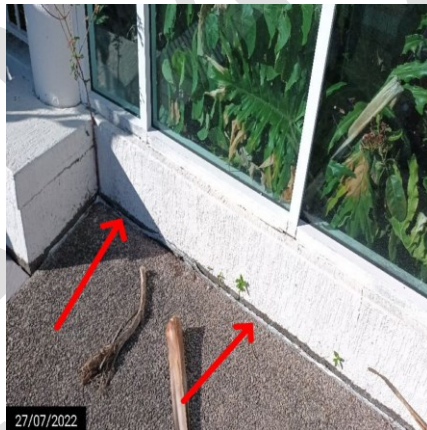
Concrete pathways along south pool area wall have sagged (up to 30mm).

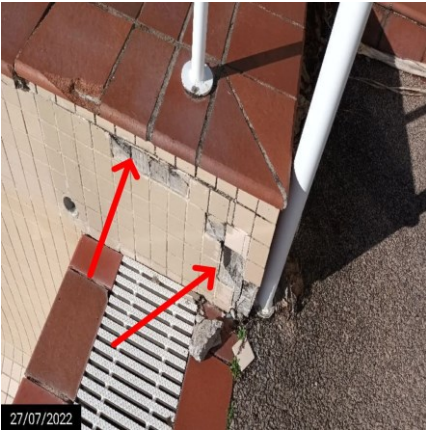
Damaged pool tiling along Southwest corner of pool shell.

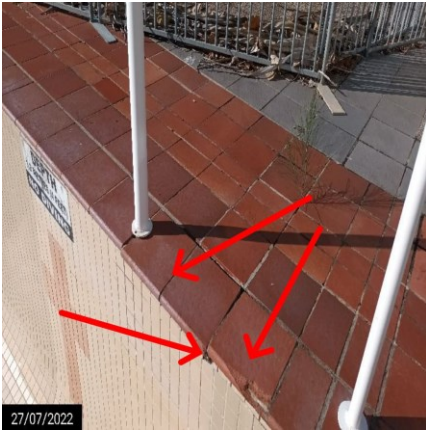
Damaged and loose capping tiles to south west corner of pool shell.

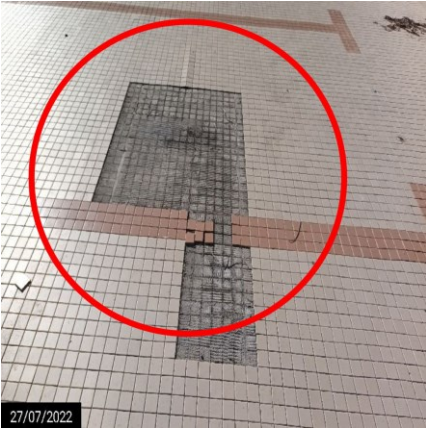
Damaged pool tiling.

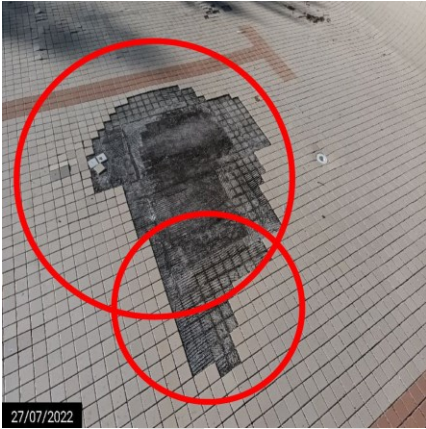
Damaged pool tiling.

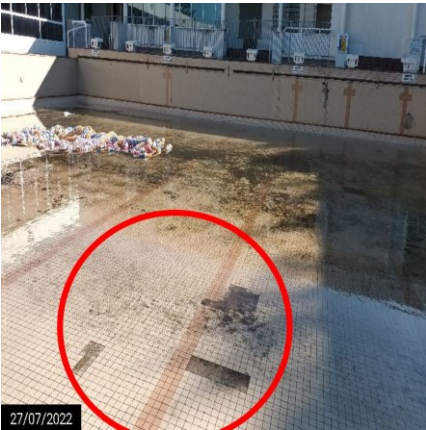
Damaged pool tiling.

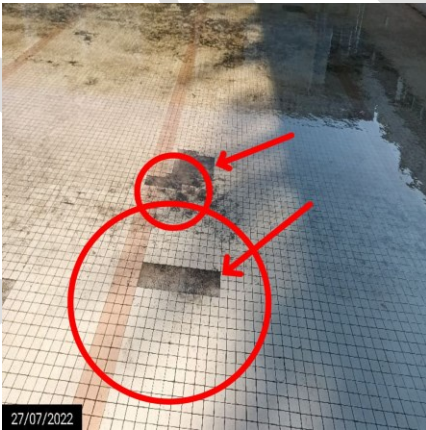
Damaged pool tiling.

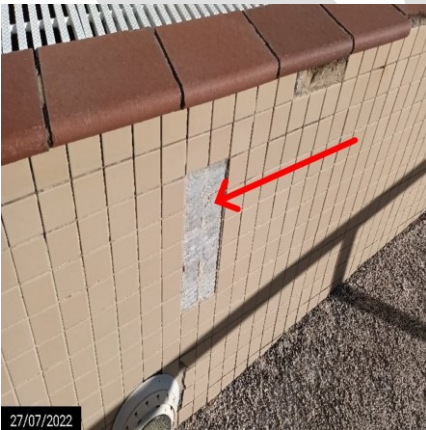
Missing wall tiling along pool ramp access area.

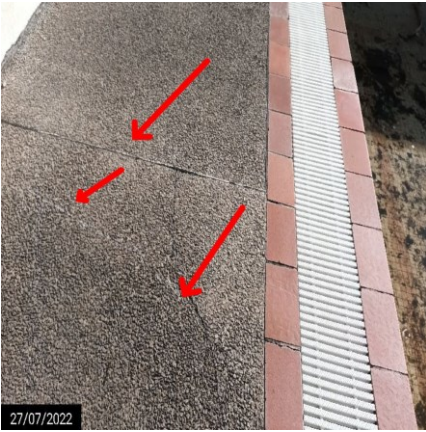
Cracking to concrete paving around pool area (up to 3mm).

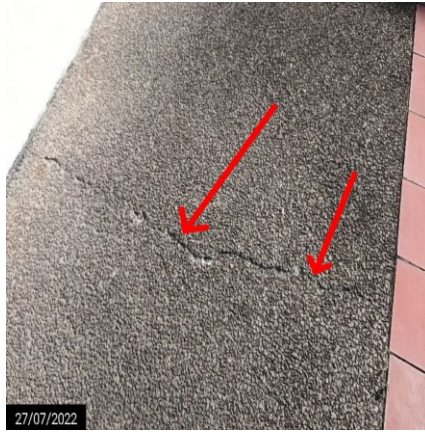
Cracking to concrete paving around pool area (up to 3mm).

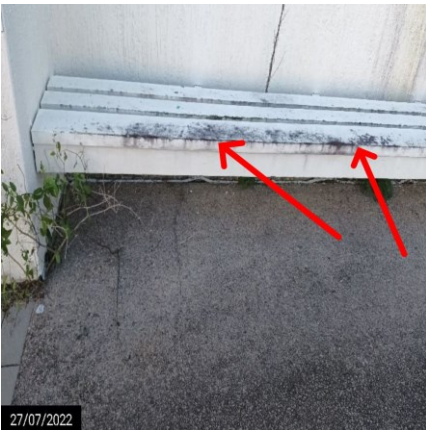
Wood decay to pool's seating.

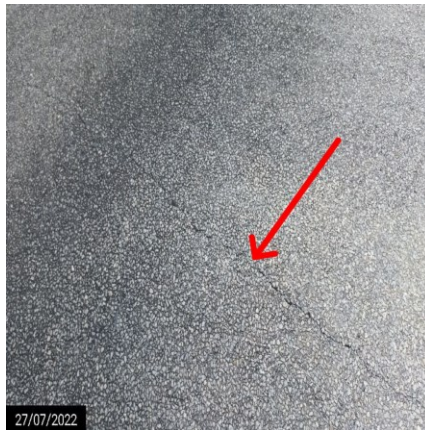
Cracking to concrete paving around pool area (up to 3mm).

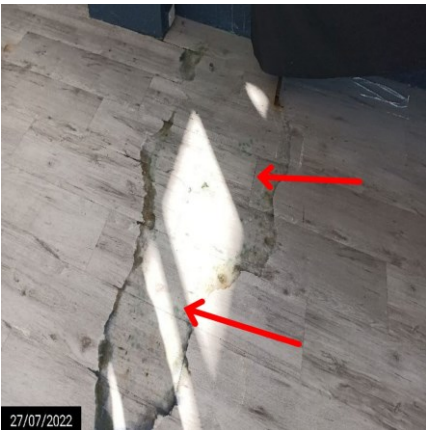
Moisture staining to activity 2 floor coverings.

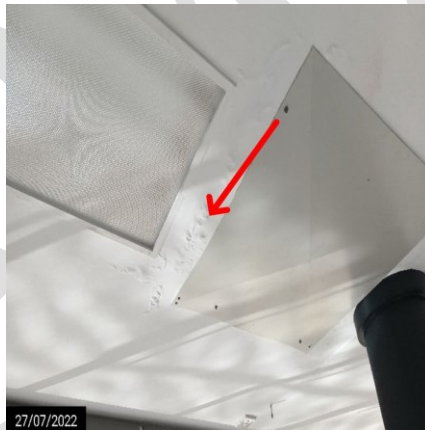
Moisture staining to activity 2 plaster ceiling linings.
